# COMBINED AQUATICS STUDY PLANS

CAWG-2-GEOMORPHOLOGY

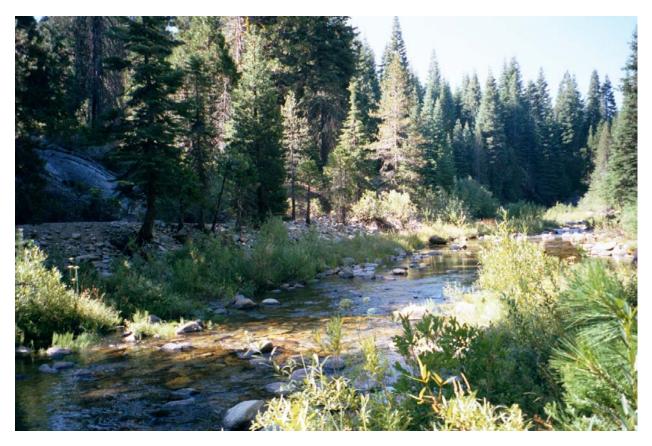
Figure CAWG-2-4. Example of limited and discontinuous potential encroachment along North Fork Stevenson Creek (RM 2.2). Willows and conifers growing on the 8 ft high gravel bar shown in photograph. It is likely that this gravel bar was not a natural feature of the channel.

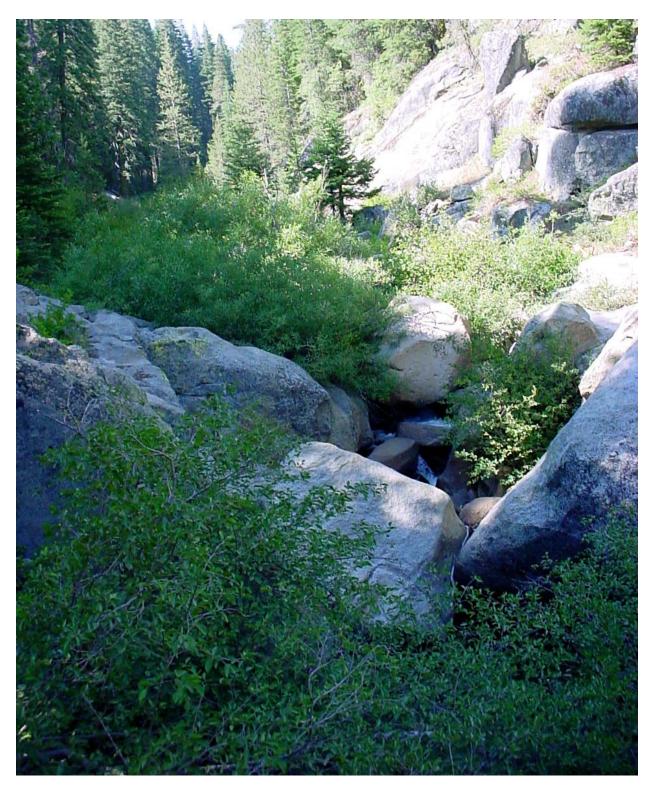
Figure CAWG-2-5. Dense and continuous potential encroachment on Big Creek below Huntington Lake. This is a steep gradient bedrock and boulder section of the channel with an A1/A2 classification (approximately RM 9.1 is shown).
