Bishop Creek Hydroelectric Project

(FERC Project No. 1394)

FINAL LICENSE APPLICATION

FINAL TECHNICAL REPORTS

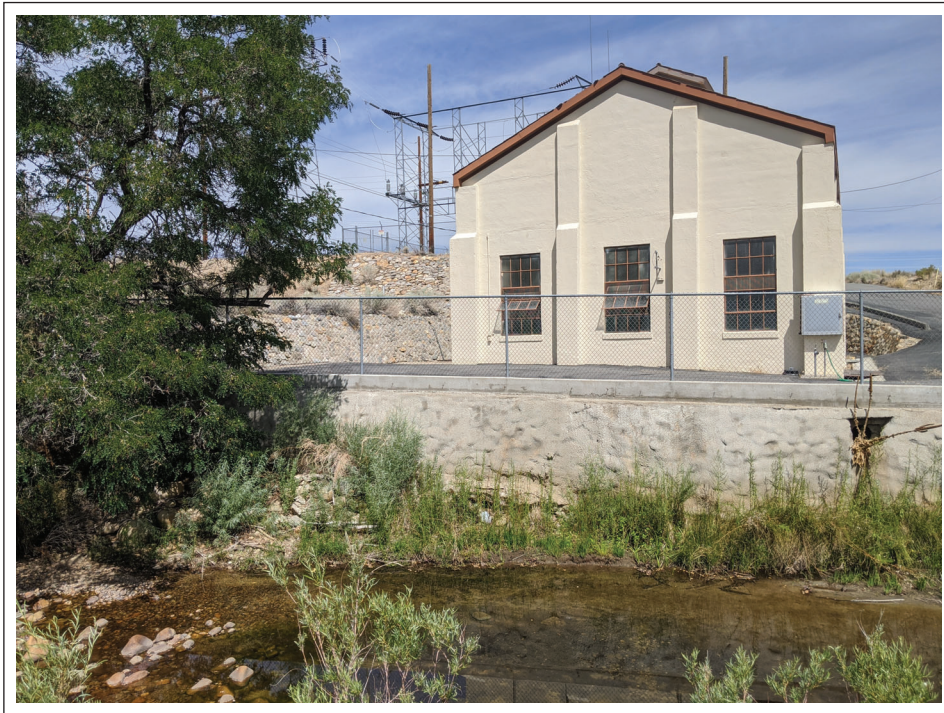
Location of the recording device at Powerhouse 6.

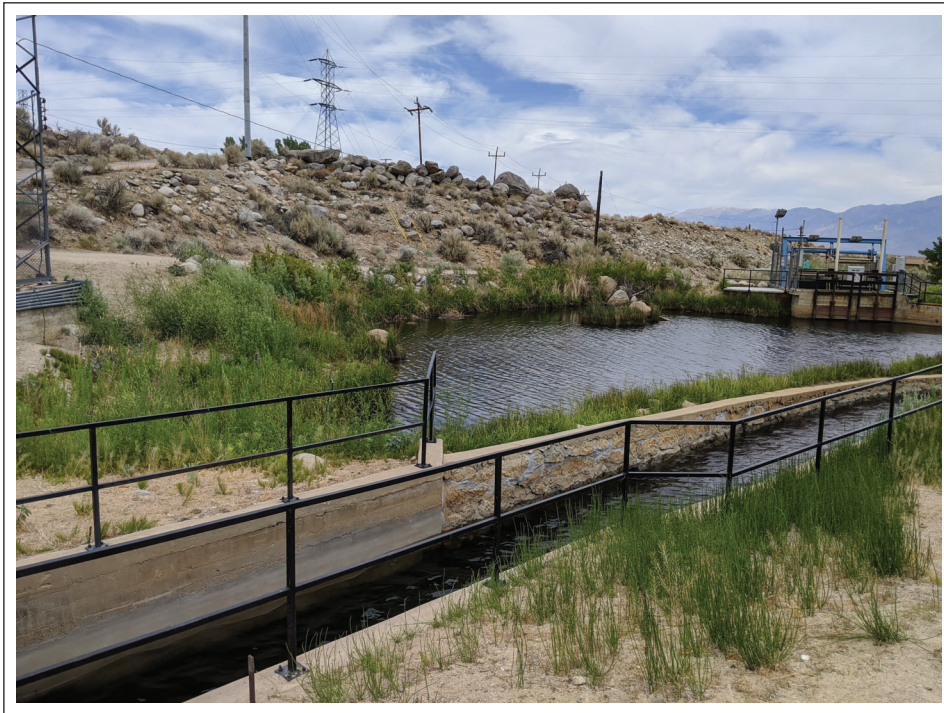
Location of the first recording device at Powerhouse 5.

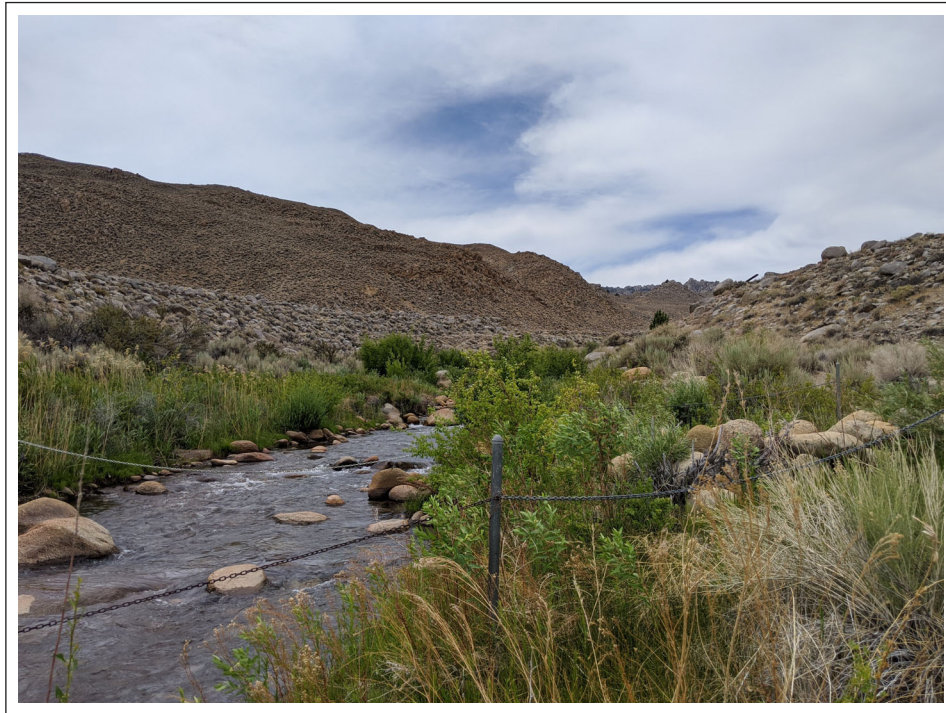
Location of the second recording device at Powerhouse 5.

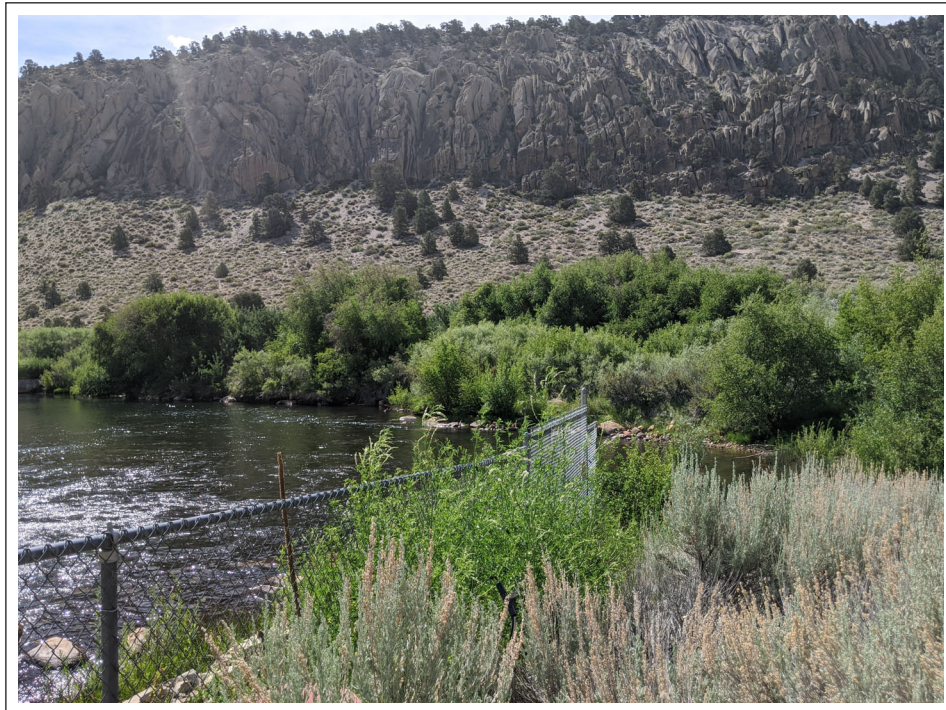
Location of the first recording device at Powerhouse 3.

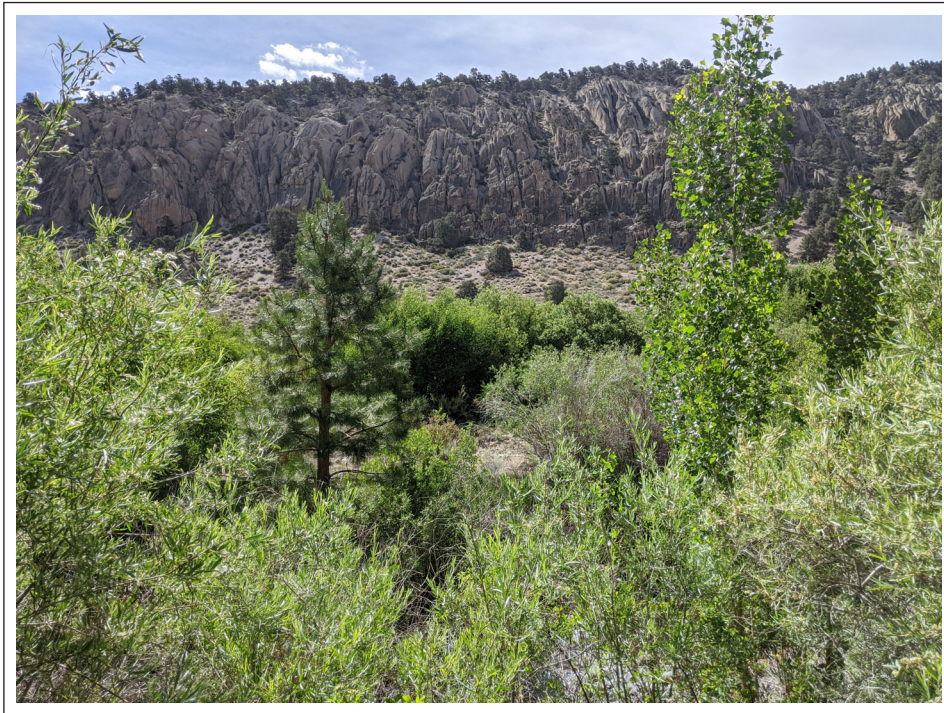
Location of the second recording device at Powerhouse 3.

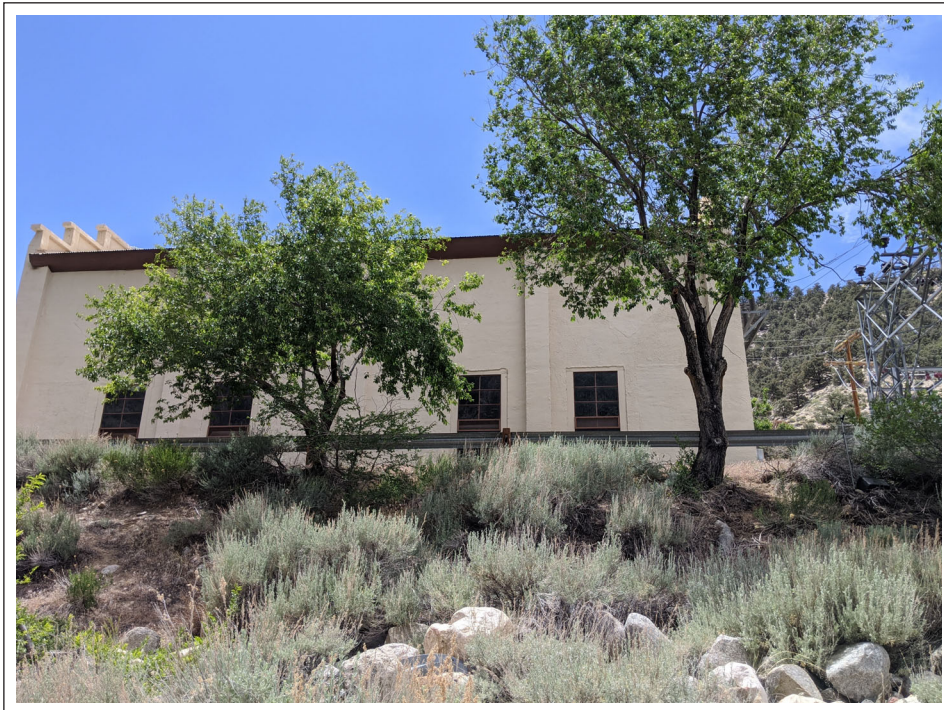
Location of the first recording device at Powerhouse 2.

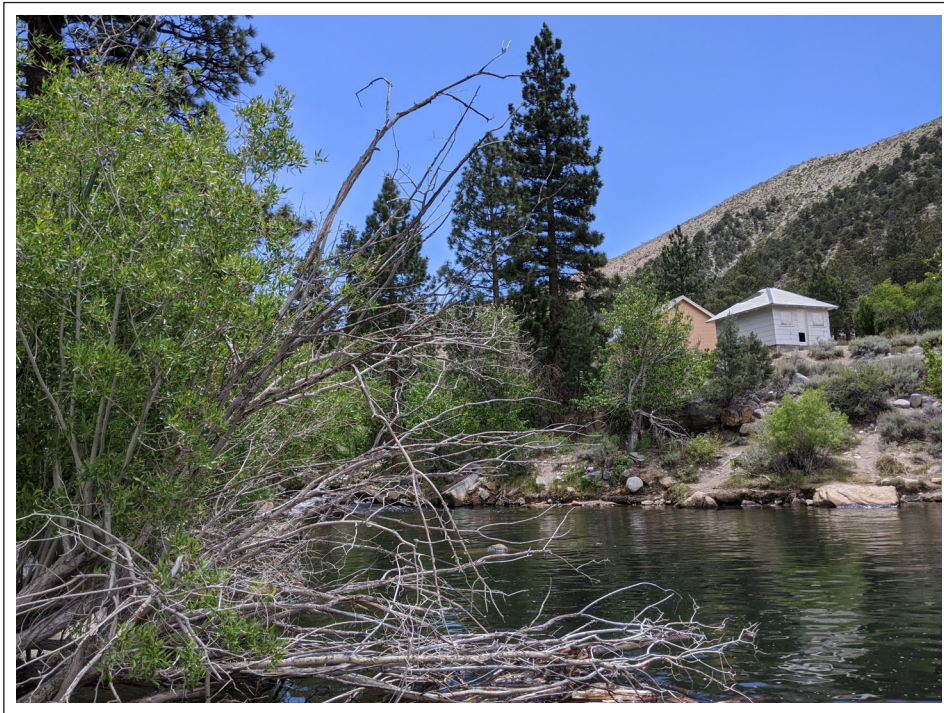
Location of the second recording device at Powerhouse 2.
