**Subject: Bishop Creek Hydroelectric Project, FERC Project No. 1394
Updated Study Report Meeting Summary**

SOUTHERN CALIFORNIA EDISON

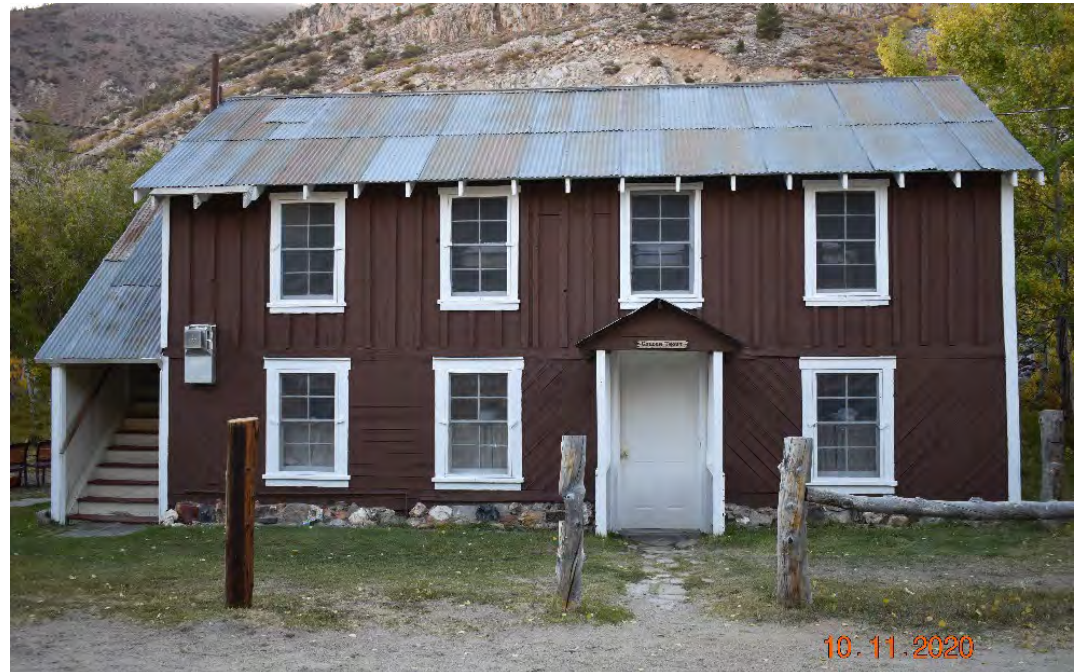
Bishop Creek Powerhouse No. 2
Constructed in 1908

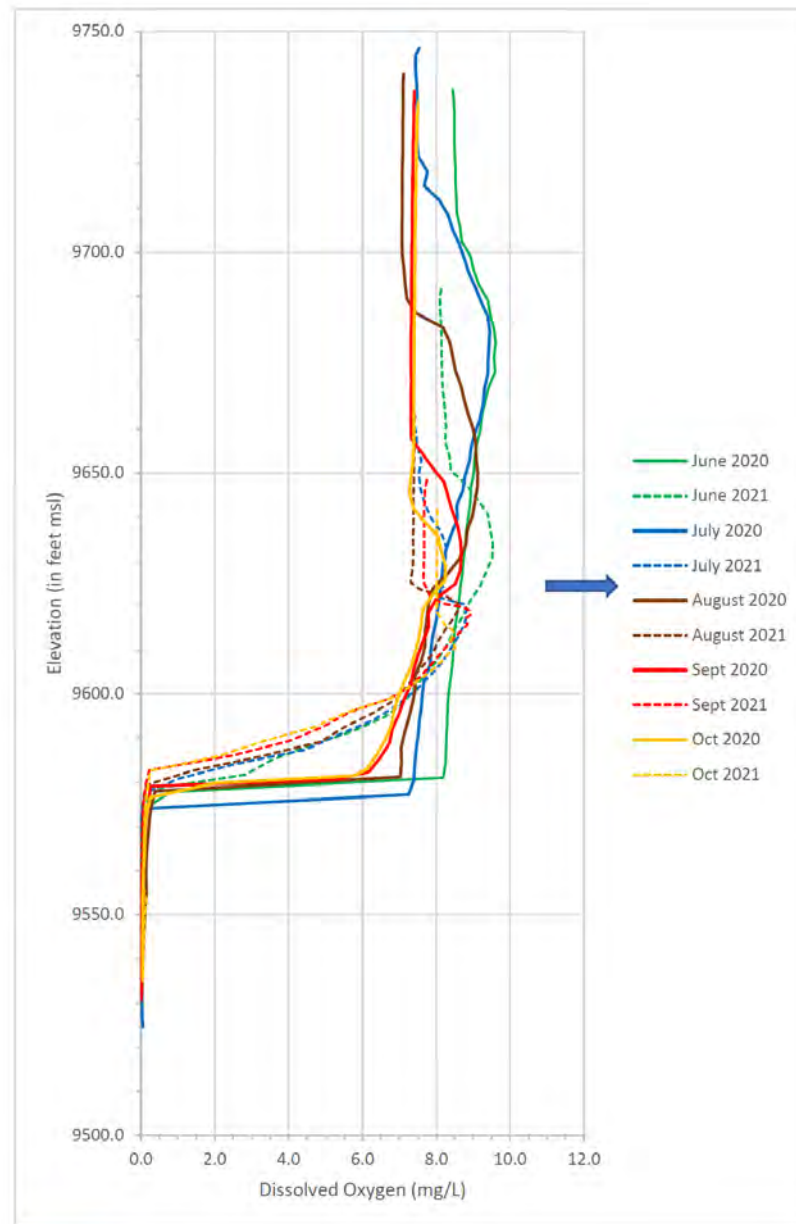
South Lake DO Vertical Profiles

➡ - Approximate depth of lake outlet.

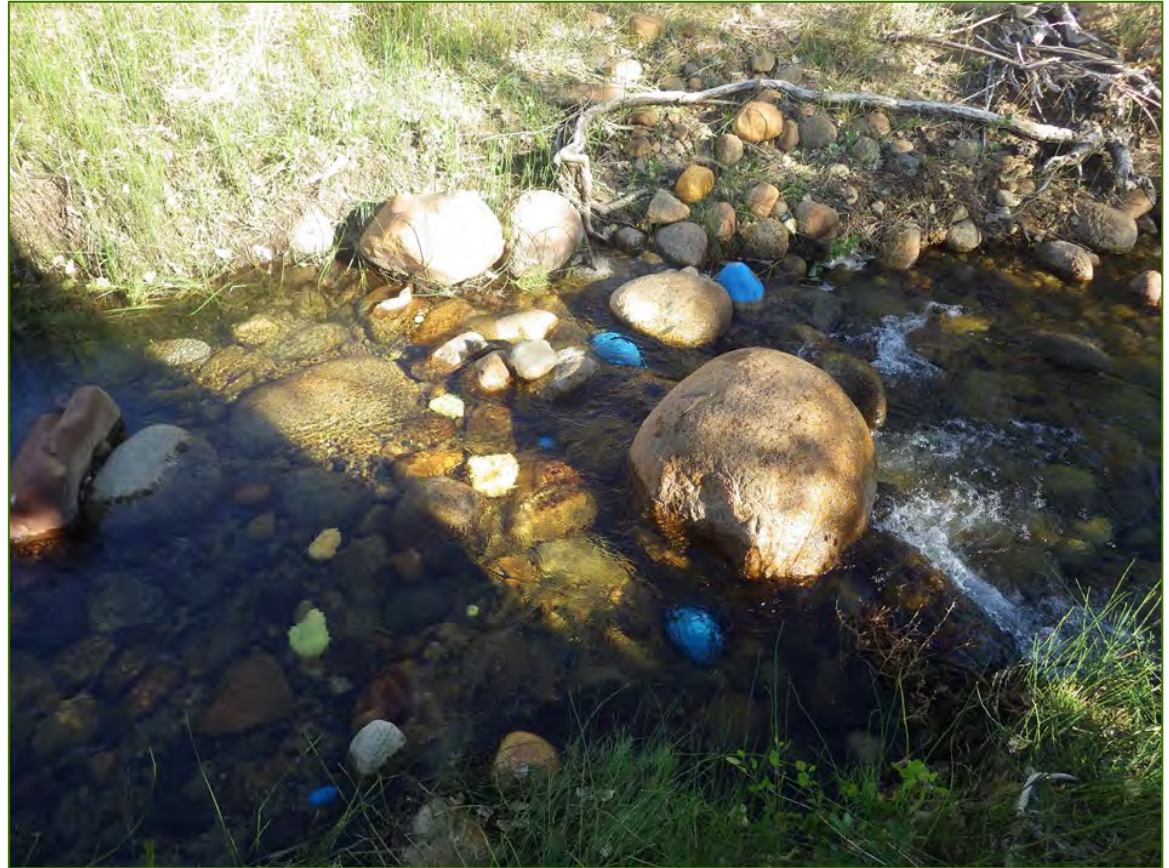
Tracer Rocks

- 116 PIT-tagged tracer rocks deployed at Site 4 in early August 2020
- 67 PIT-tagged tracer rocks deployed at Site 6 in early August 2020
- Tracers surveyed with RTK-GNSS and total station equipment

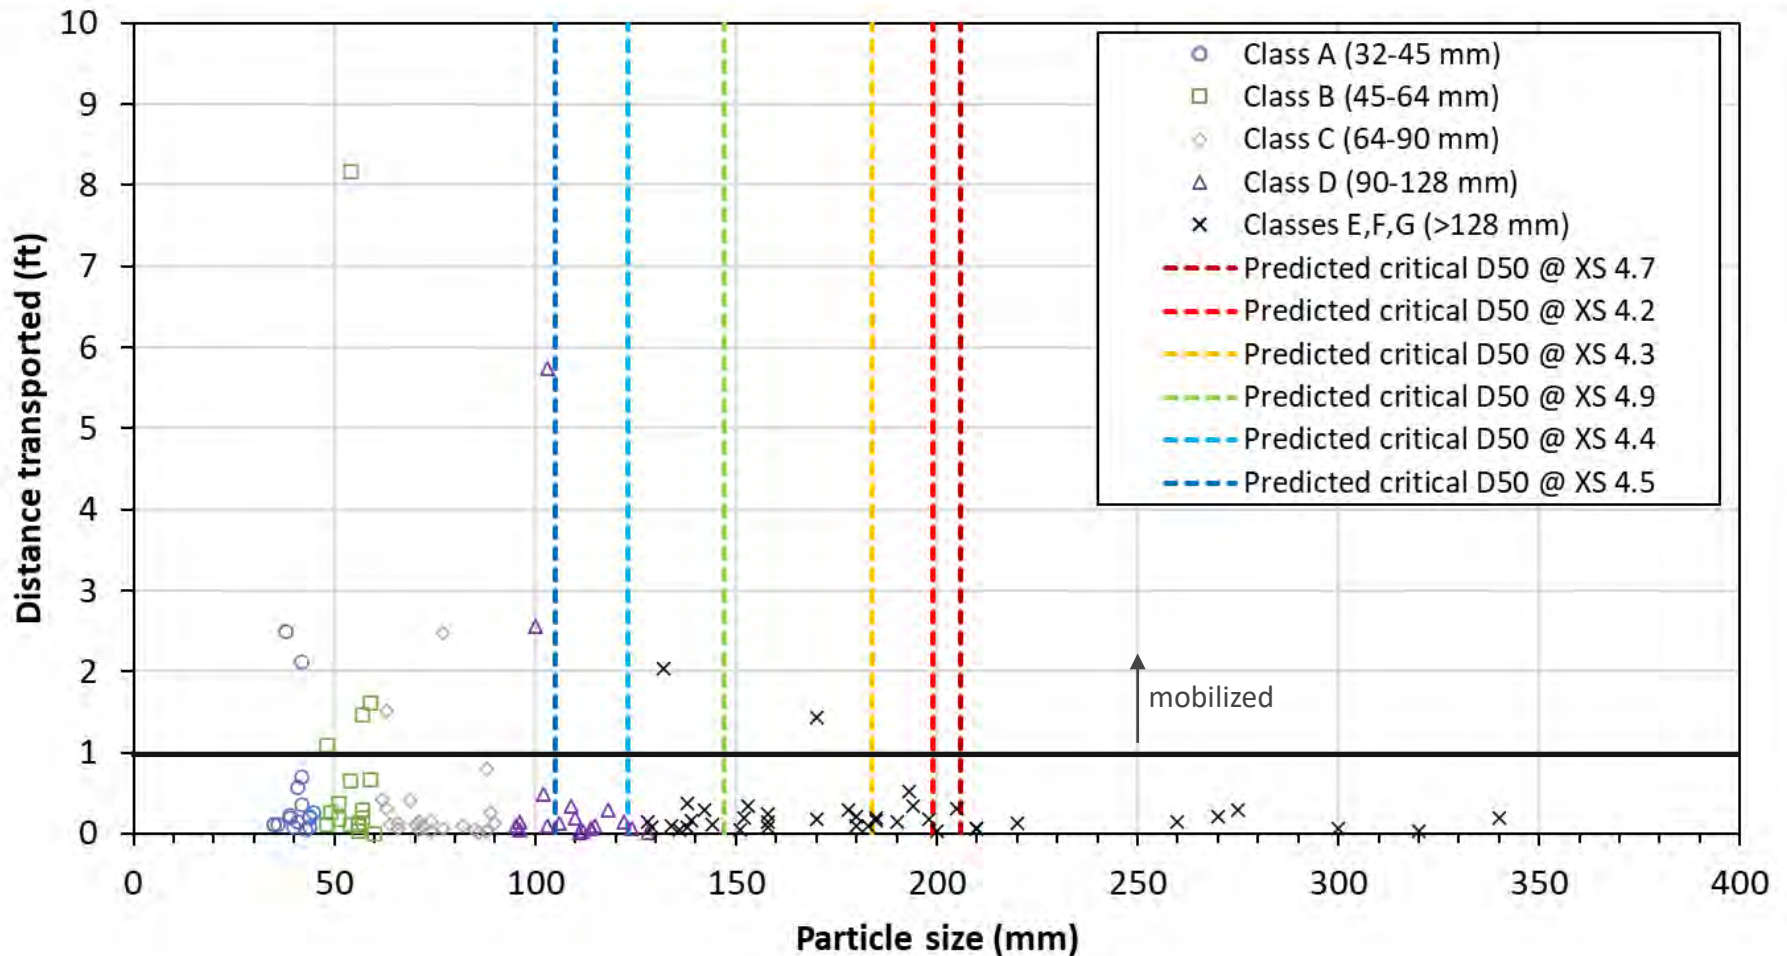
Site 4

Peak flow ~120 cfs

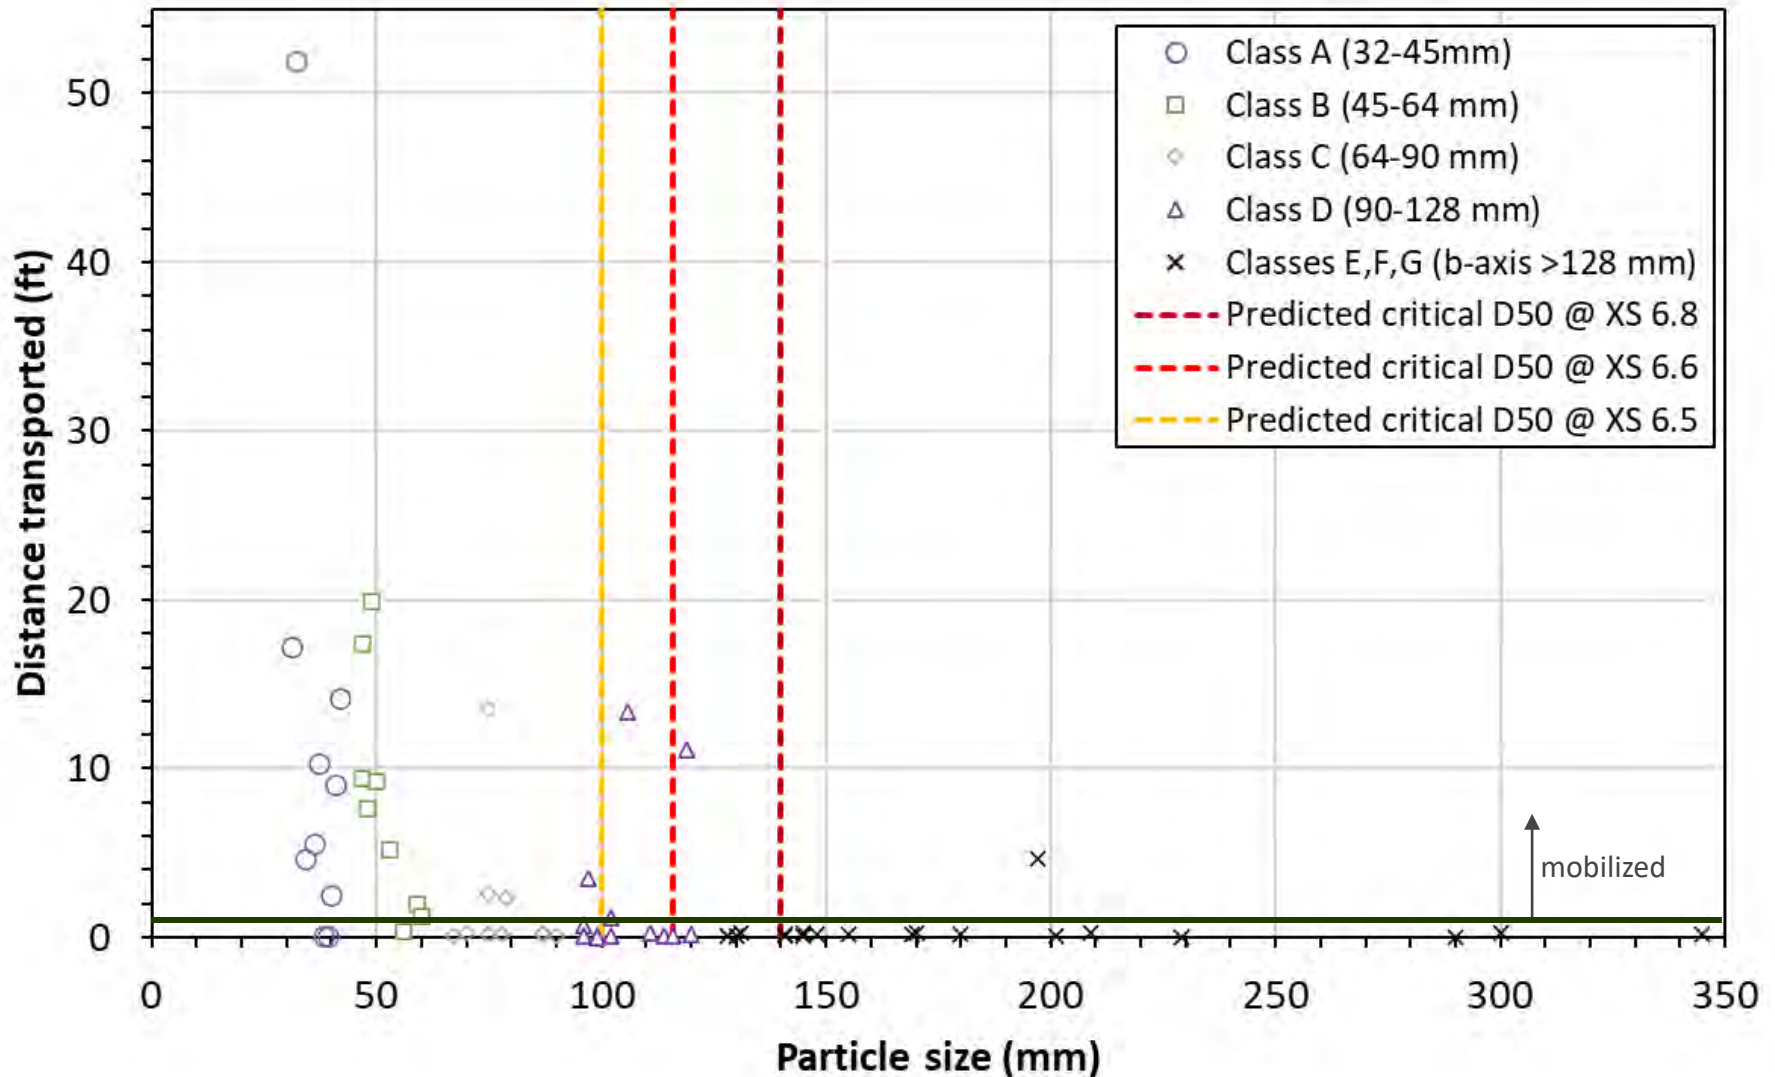
Site 6

Peak flow ~120 cfs

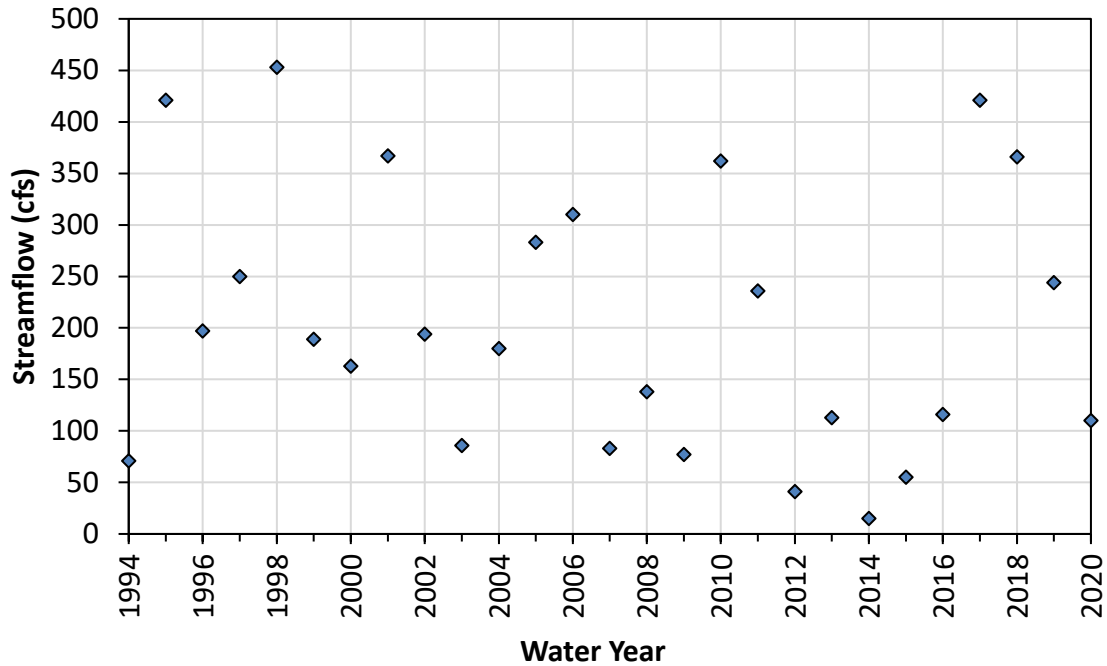
Figure 2. Instantaneous maximum annual peak flow record for water years 1994–2020 at USGS Gage ID 10271200 (Site 6)

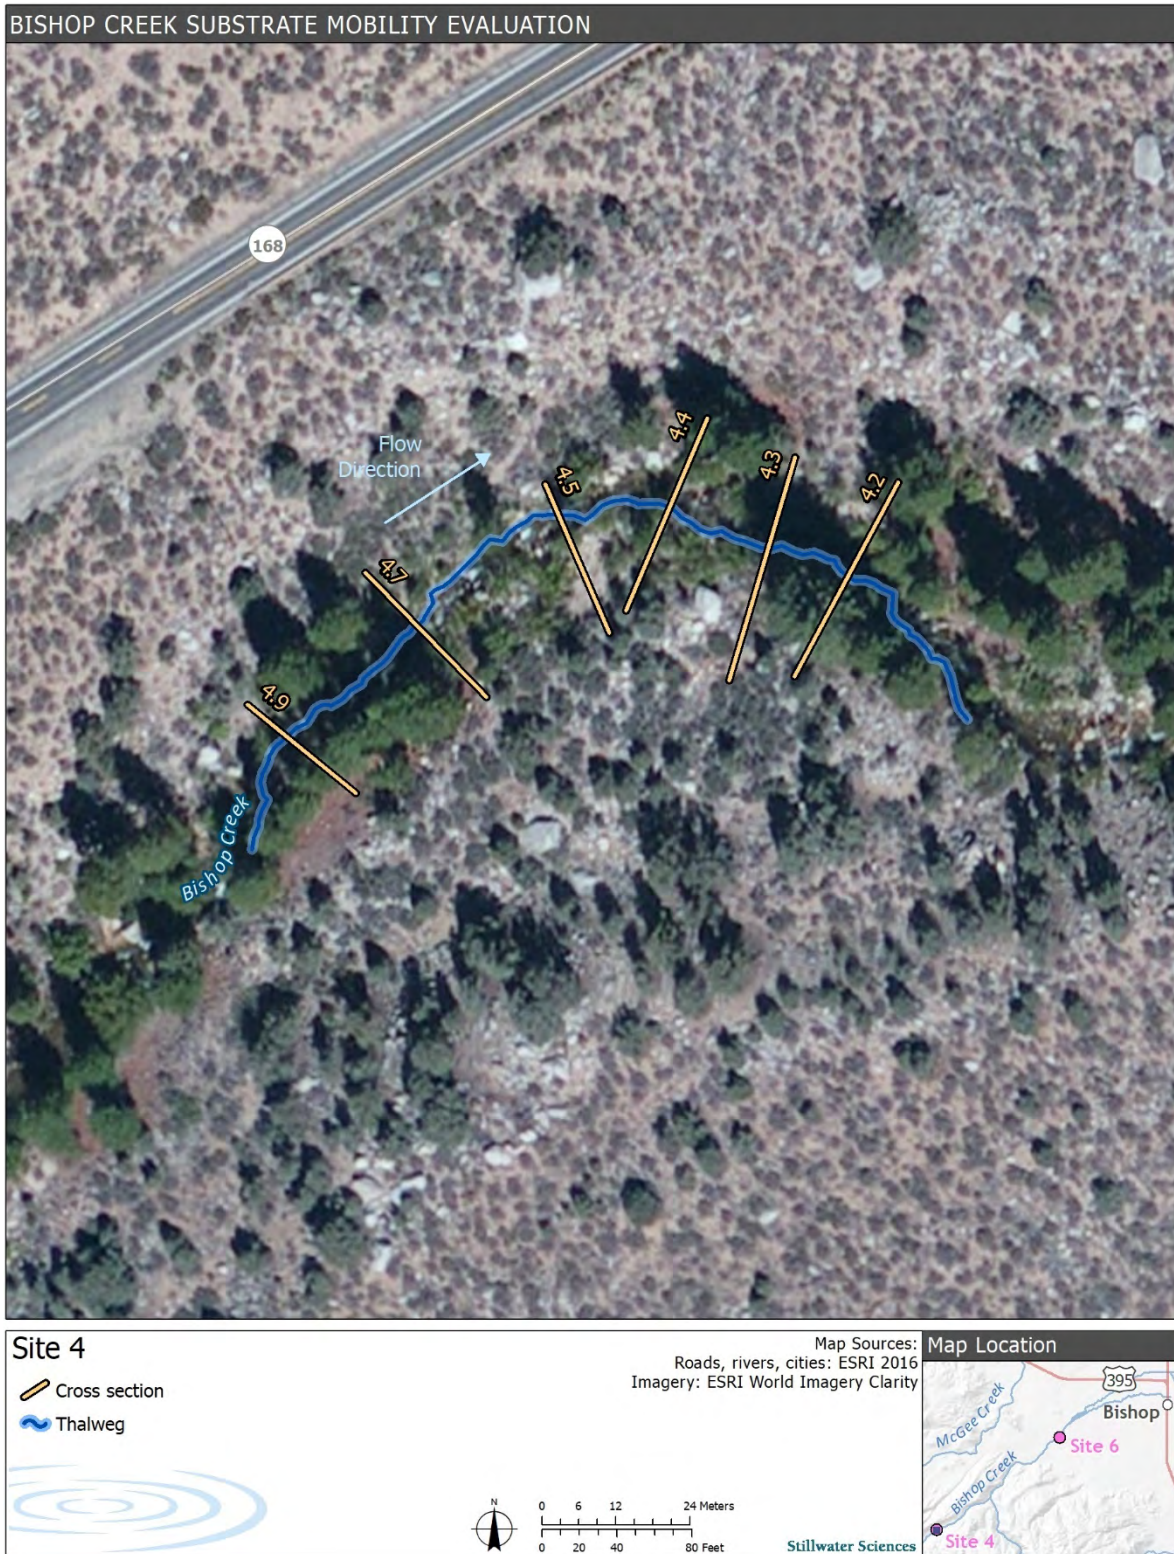
Figure 4. Site 4 overview

The following sections provide results from the 2020 surveys (during tracer installation) at Site 4 and a comparison with data collected in 2019 during separate study elements. Due to the limited mobility of the tracers observed during the tracer recovery efforts in 2021 at this site, the profile and cross section were not resurveyed. An overview of Site 4 and the survey extents are provided in Figure 4.

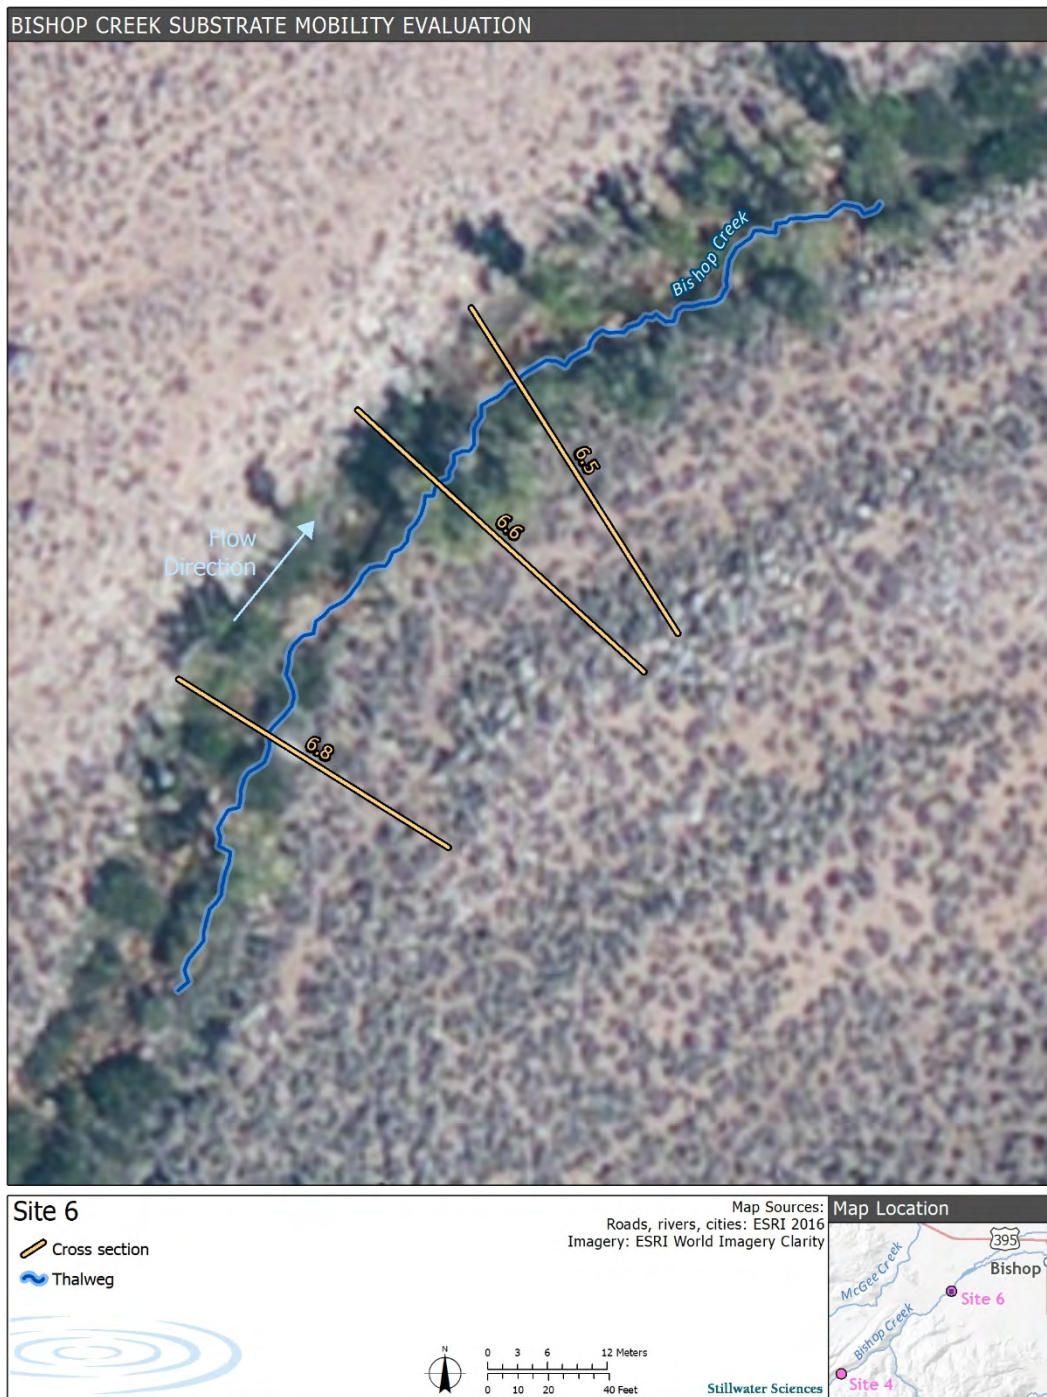
Figure 13. Site 6 overview.

The following sections provide results from the 2020 (tracer deployment) and 2021 (tracer recovery 1 and 2) surveys at Site 6, and a comparison with data collected in 2019 during a separate study element. An overview of Site 6 and the survey extents are provided in Figure 13. Cross sections are numbered sequentially from downstream to upstream.

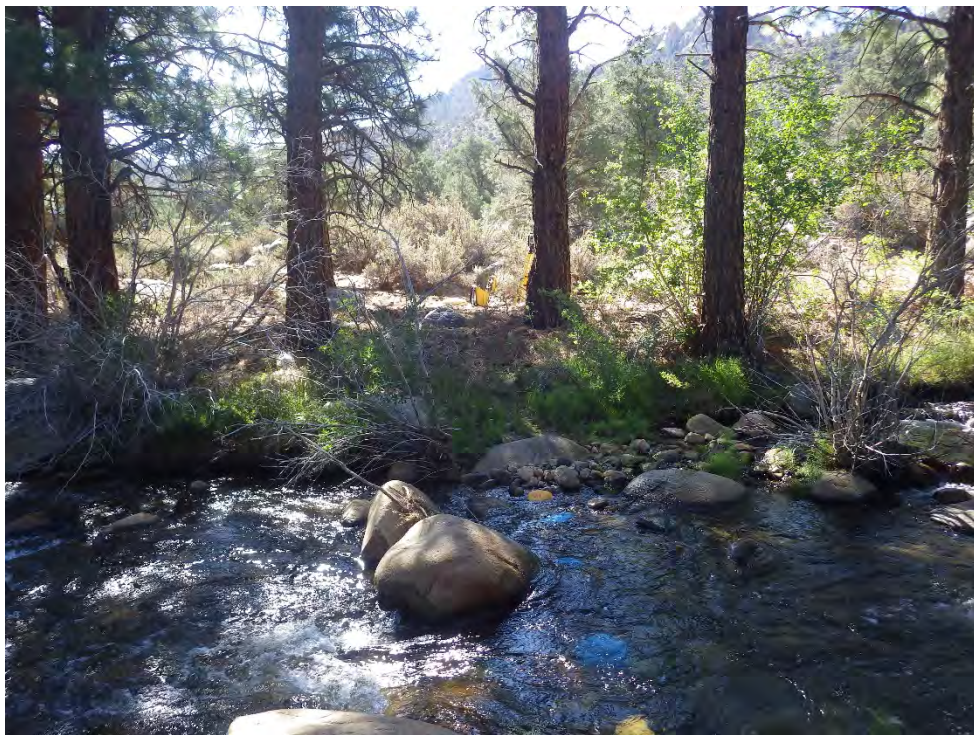
Figure A-4. Cross section 4.9 in August 2020, view of right bank from left bank.

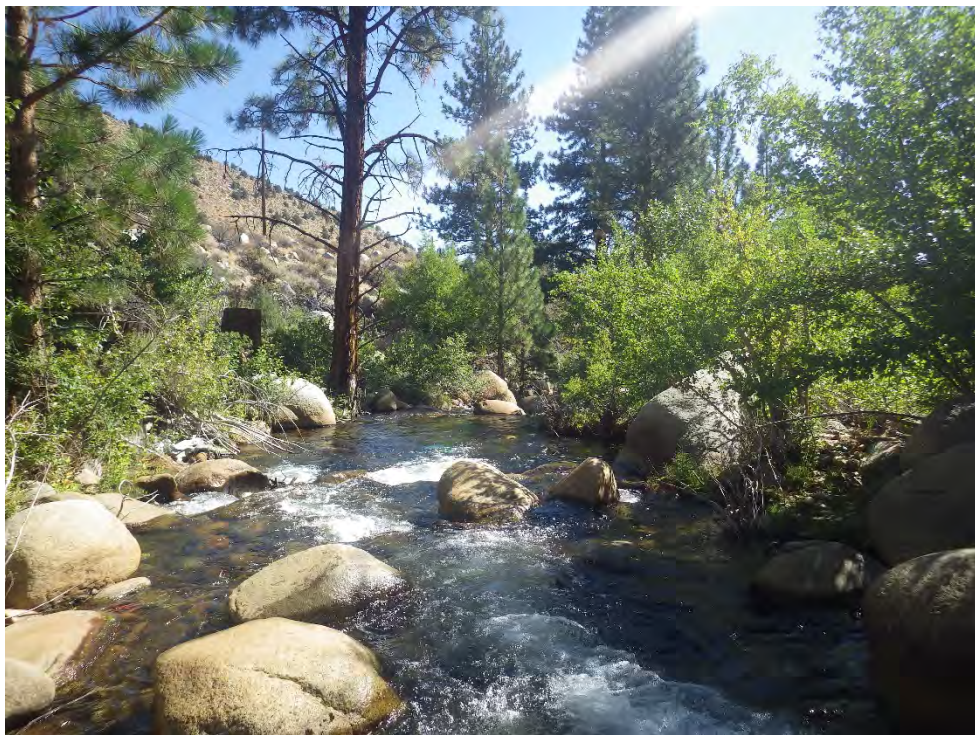
Figure A-12. Cross section 4.7 in August 2020, view downstream from mid channel.
