Bishop Creek Hydroelectric Project

(FERC Project No. 1394)

DRAFT LICENSE APPLICATION

TECHNICAL REPORTS

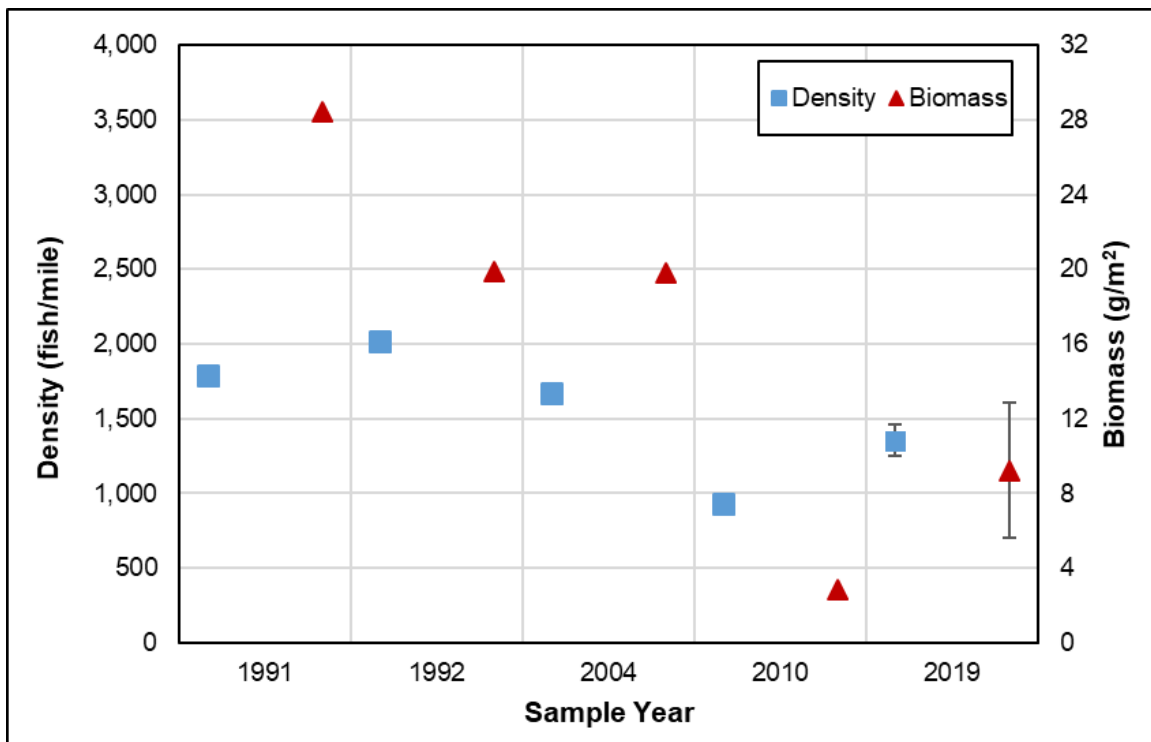
Figure 6.5-2 Brown Trout Estimated Density and Biomass in Bishop Creek at the Sada 3 Sample Site during 2019 (with 95% Confidence Intervals) and Previous Studies

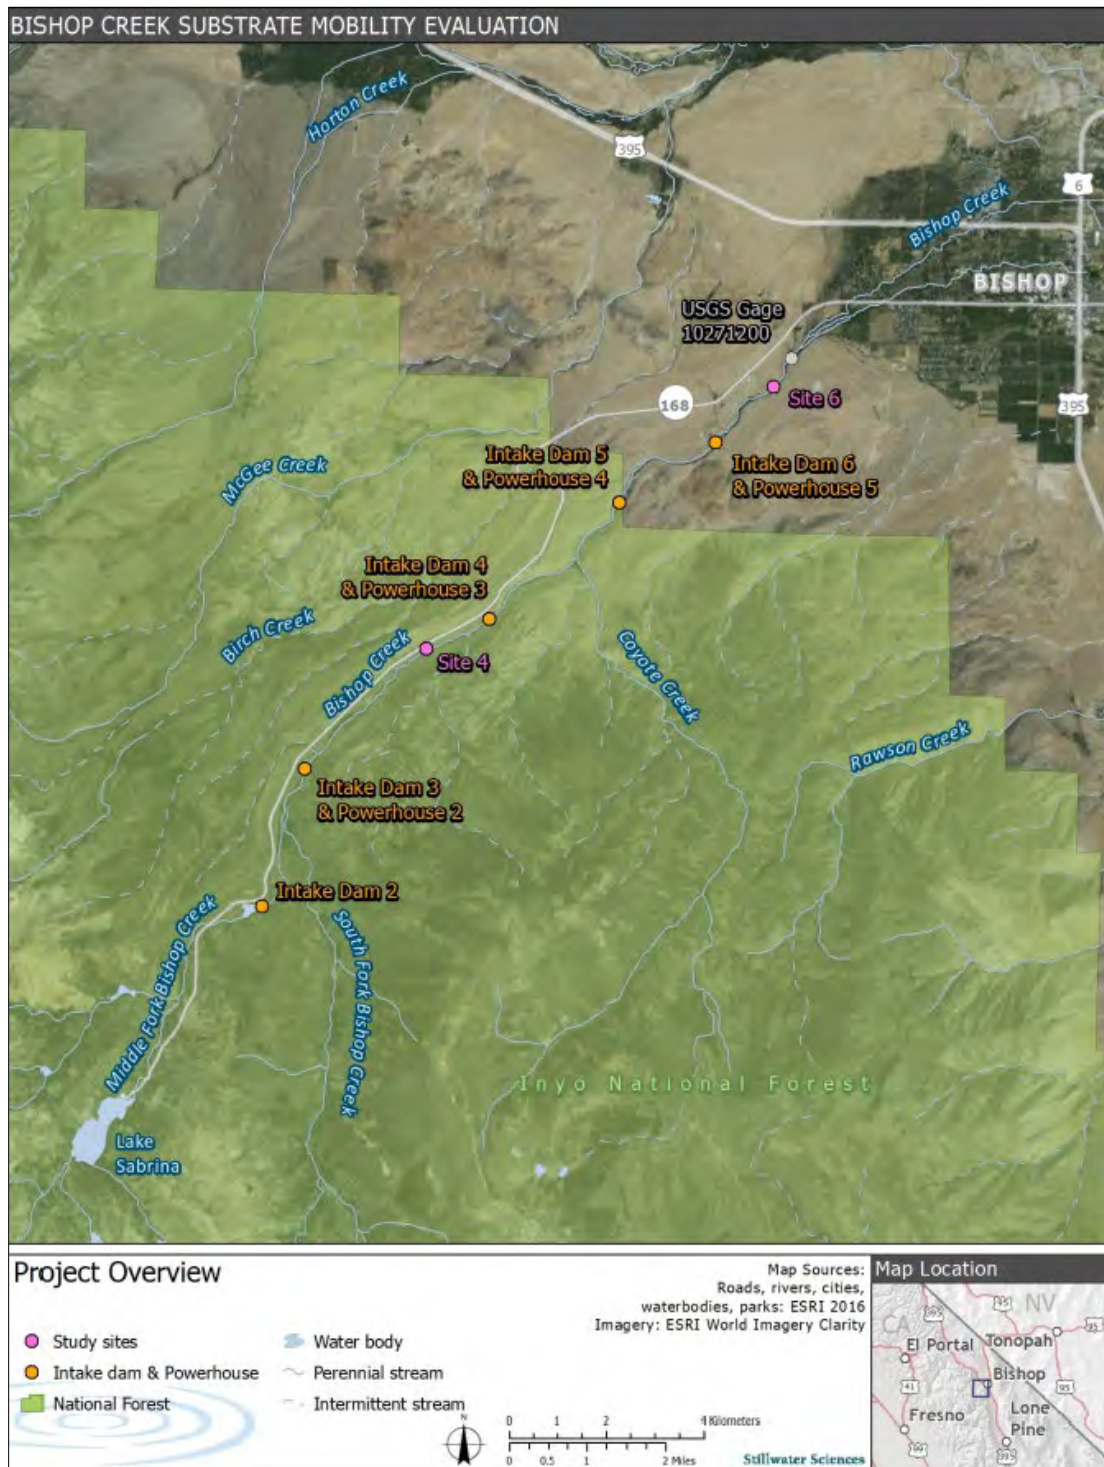
Figure 6-3 Bishop Creek Tracer Rock Evaluation Study Sites

As detailed in Sections 4.4 and 5, a Substrate Mobility Evaluation Study was completed to further characterize the particle size distribution of sediments mobilized at or near bankfull flow conditions. PIT tagged rocks were deployed to inform sediment transport dynamics at Sites 4 (comprised on Sites 4.1 and 4.2) and 6 on Bishop Creek (Figure 6-8). The tagged tracer rocks were deployed along cross sections, and at other representative geomorphic units between the cross sections, at each study site. Field measurements taken during the study included cross section surveys, longitudinal profile surveys of the channel bed and water surface, surface measurements of bed particle size distribution, deployment and recovery of PIT tagged tracer rocks, and photo documentation. The full report on substrate mobility in Bishop Creek is included as Appendix A to this report, with a summary of the results provided in Section 6.4.1.

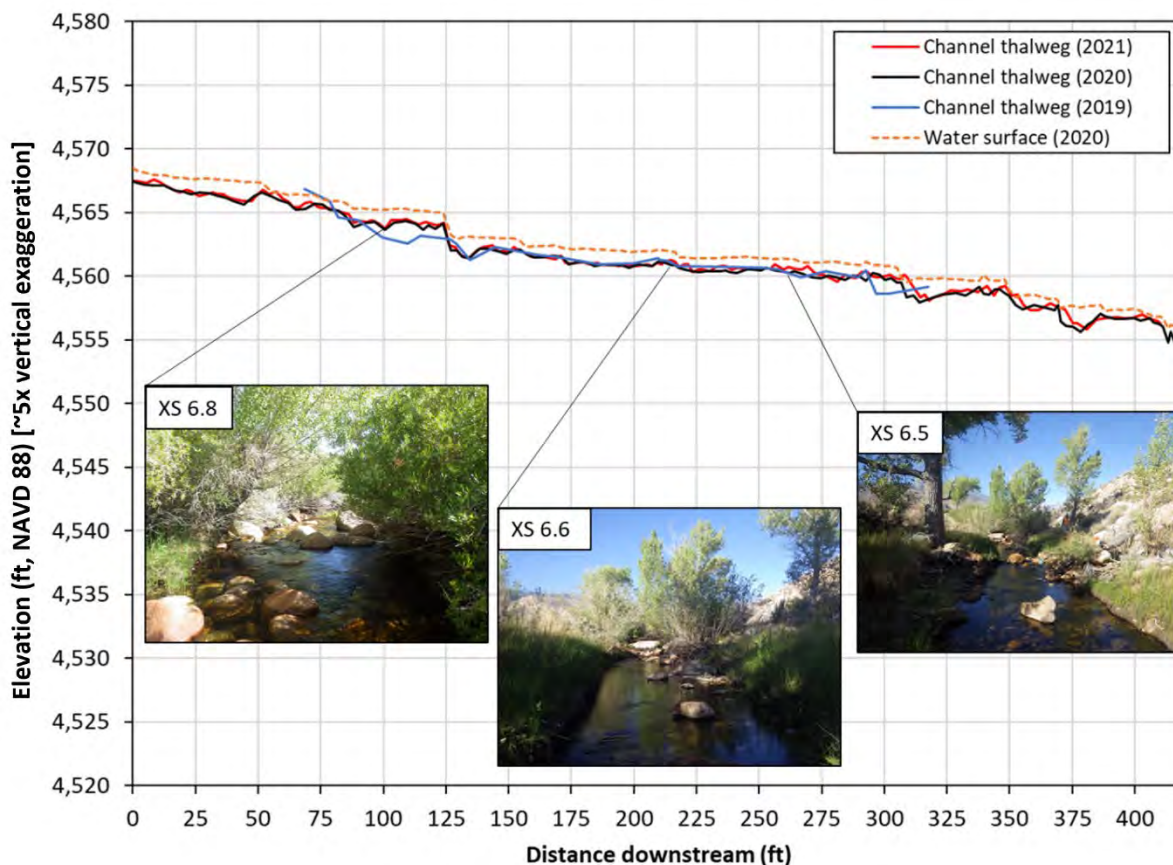
Figure 14. Site 6 longitudinal profiles from 2019, 2020, and 2021. Leader lines indicate cross section locations along longitudinal profile. Inset photos show representative conditions of each cross section during 2020 surveys.

best-fit line to the long profile, was 0.02 (2%) during all three monitoring years. The 2020 and 2021 longitudinal profiles are generally similar, and apparent differences in the two profiles are likely a result of slight misalignment or variability in survey point locations rather than changes in channel morphology. Apparent changes between the 2019 and the 2020 long profiles, particularly between stations 75 and 125, suggest channel aggradation but may be a result of misalignment and/or different survey point spacing.
