MEMORANDUM

To:Mr. Finlay Anderson
Kleinschmidt Group**From:**Brad R. Blood, PhD
Steve Norton
Psomas**Subject:**Results of a Bat Roost Habitat Assessment Conducted for the Bishop Creek
Hydroelectric Relicensing Project in Inyo County, California

Bishop Creek Hydroelectric Project

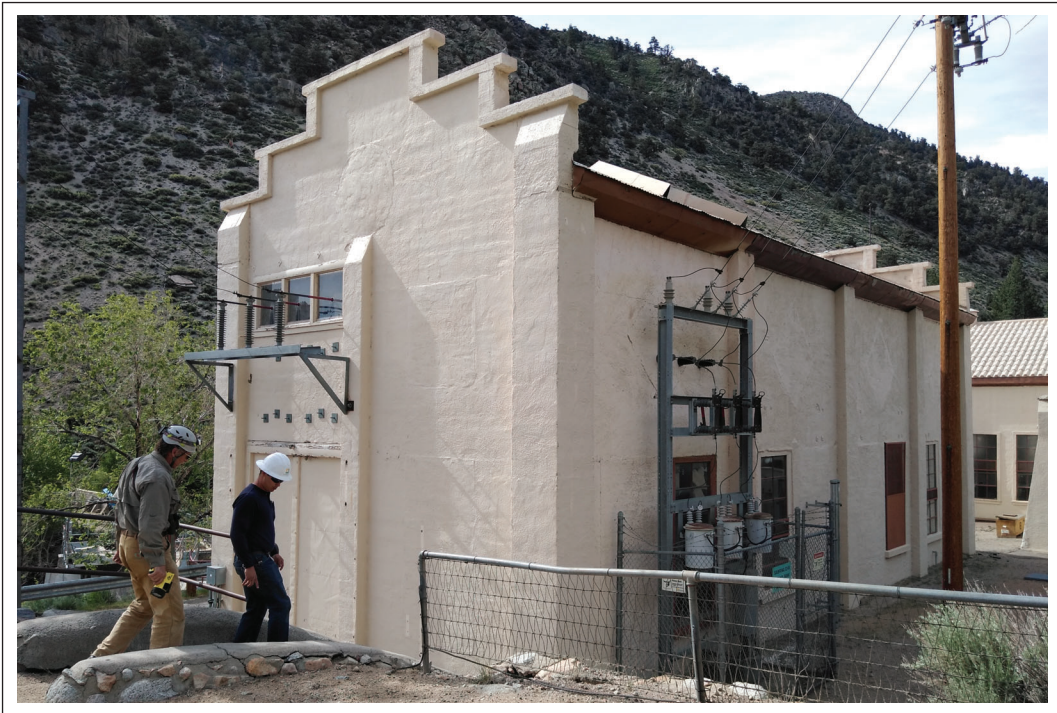
Attachment B-1

Powerhouse No. 2: Exterior view of the transformer shed facing southeast. The transformer shed is presumed to be supporting an active maternity roost.

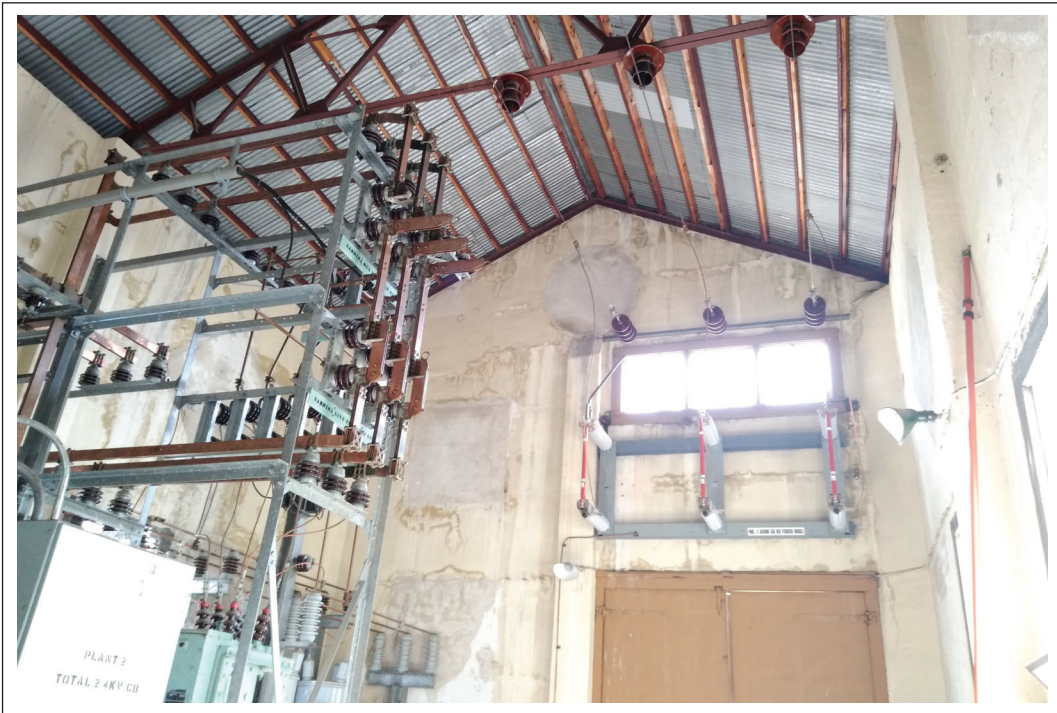
Powerhouse No. 2: Interior view of the transformer shed facing north. Bats were roosting inside the crest of the ceiling between the rafter beams.

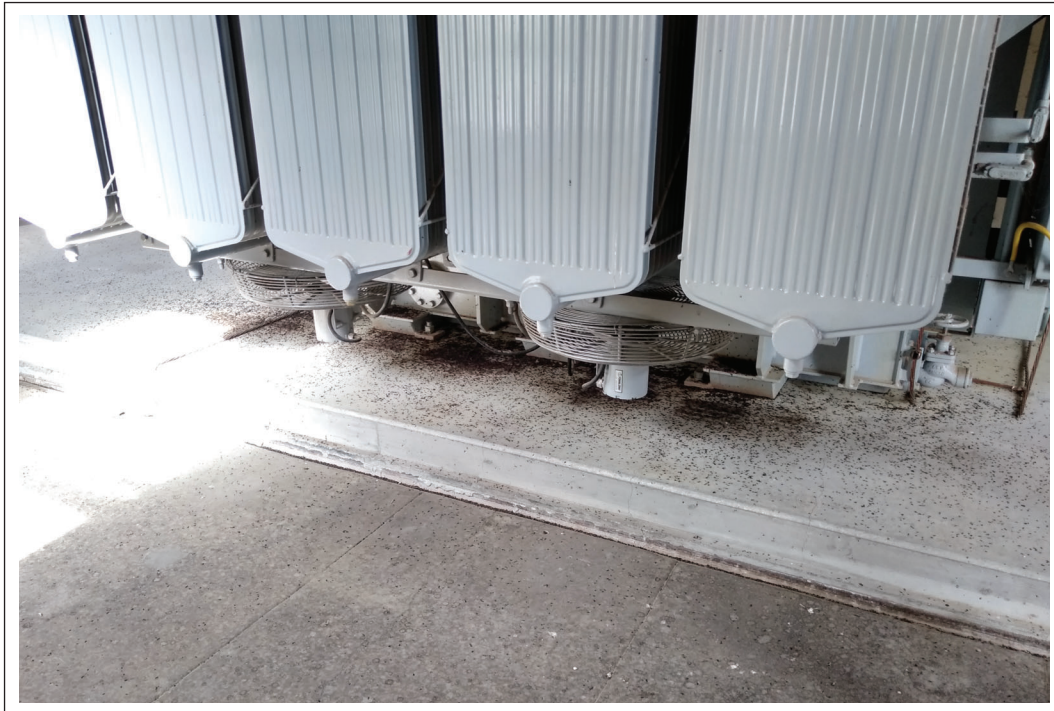
Attachment B-2

Powerhouse No. 2: Interior view of the floor of the transformer shed facing west. Substantial guano had accumulated below the equipment since it was last cleaned (likely within the last month).

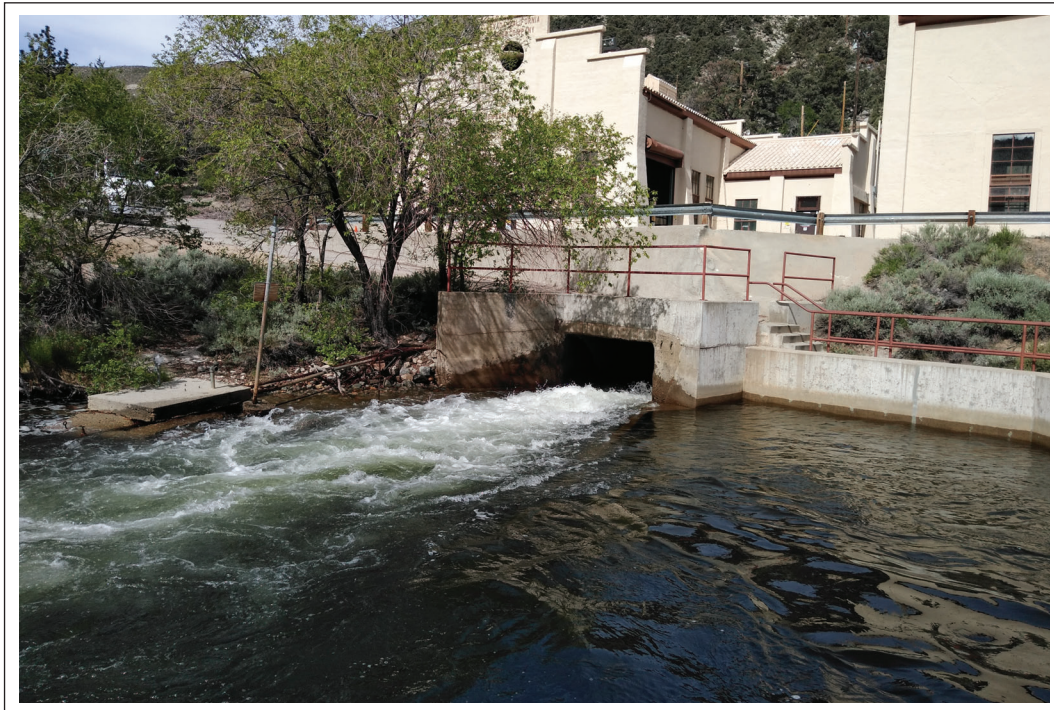
Powerhouse No. 2: View of the tailrace facing southwest. The volume of water expelled during facility flushing events does not completely inundate this tailrace leaving marginal suitable bat roosting habitat.

The tailraces at Powerhouses No. 6, No. 5, and No. 2 have limited potential to support roosting bats; however, they are not accessible for daytime visual surveys.

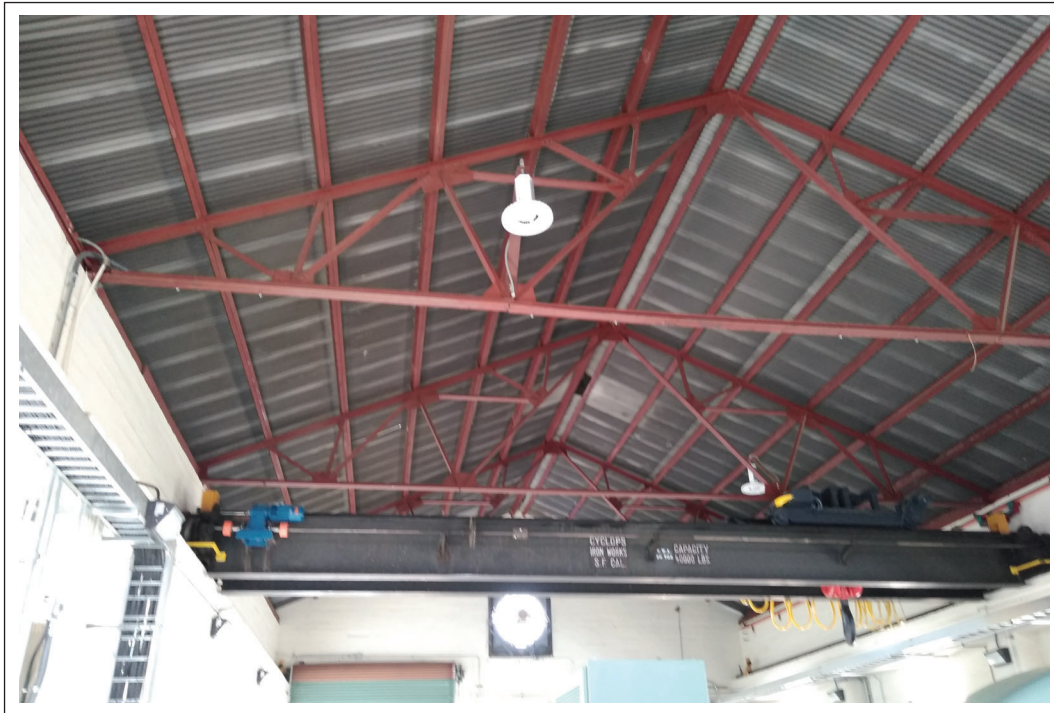
Attachment B-3

Powerhouse No. 3: Interior view of the powerhouse facing west. The roof and ceiling design are similar to Powerhouse 2 transformer shed, however, no evidence of day-roosting was observed.

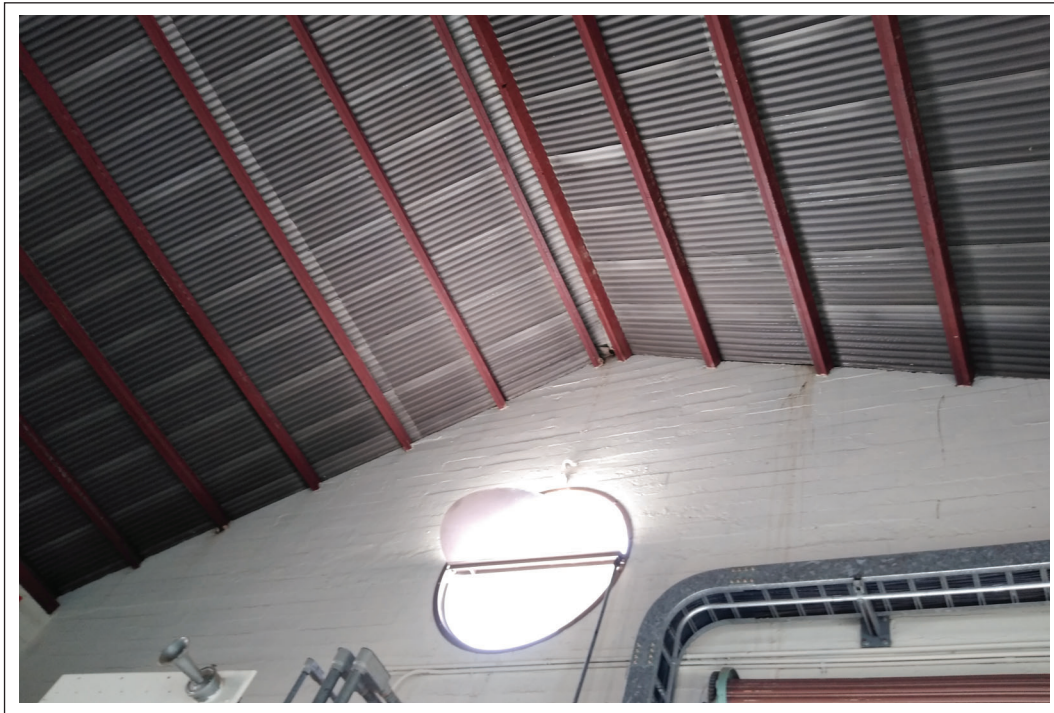
Powerhouse No. 3: Interior view of the powerhouse facing east. The circular vent present at many of the facilities is a good entrance/emergence feature for bats. Evidence of night roosting (urine staining) is visible on right side of photograph.

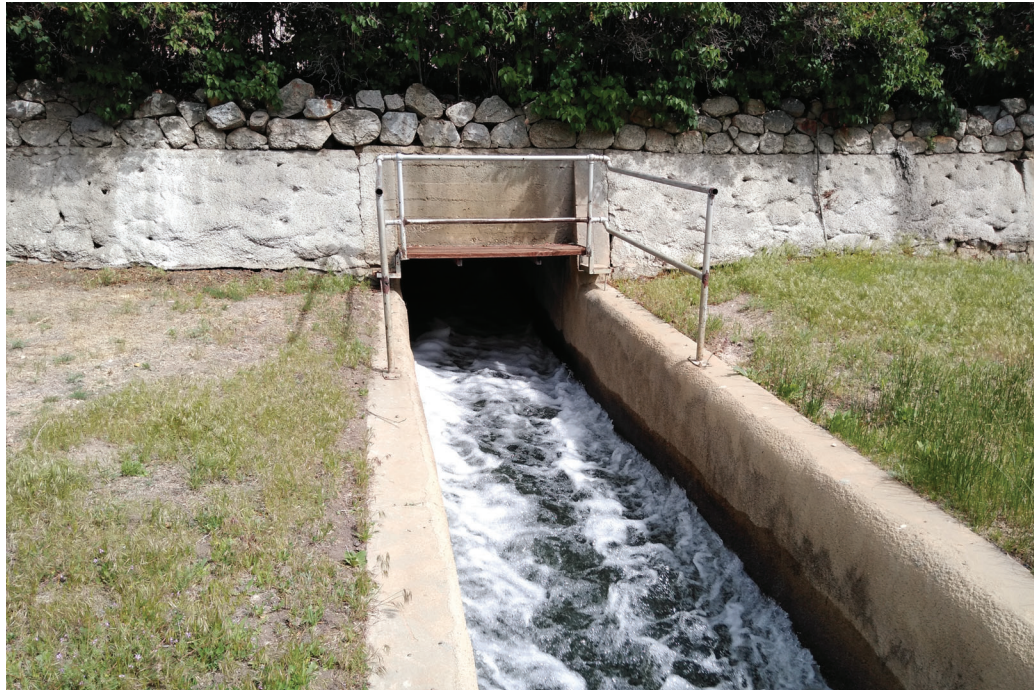
Attachment B-4

Powerhouse No. 3: View of the tailrace facing northwest. This smaller tailrace is completely inundated during facility flushing events and has no potentially suitable bat roosting habitat.

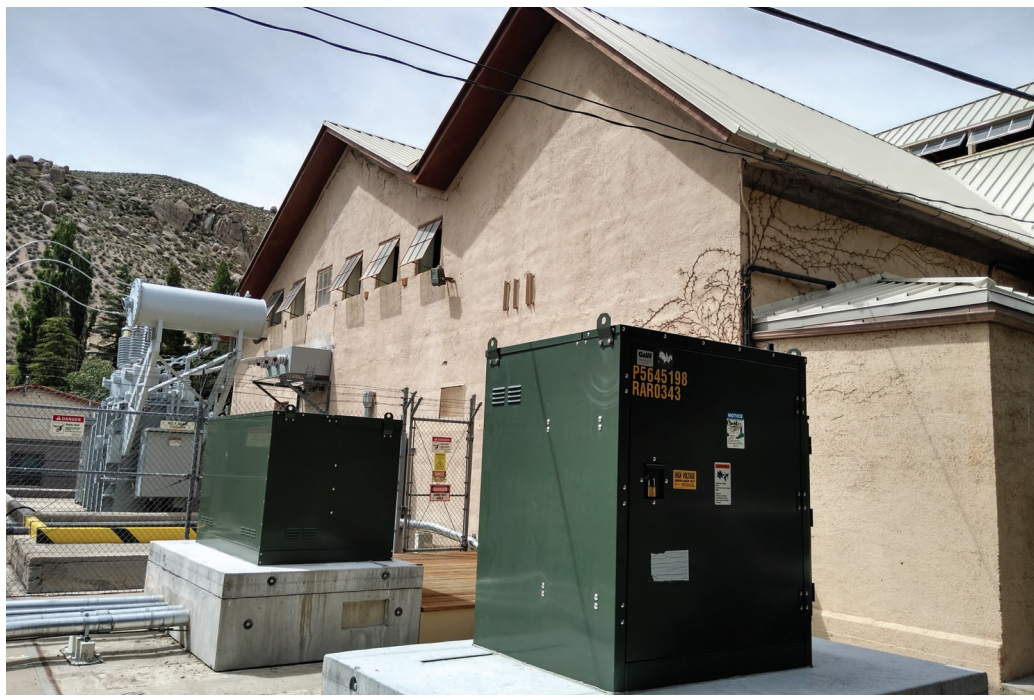
Powerhouse No. 4: Exterior view of the powerhouse facing south. No sign of bat roosting was observed at this facility.

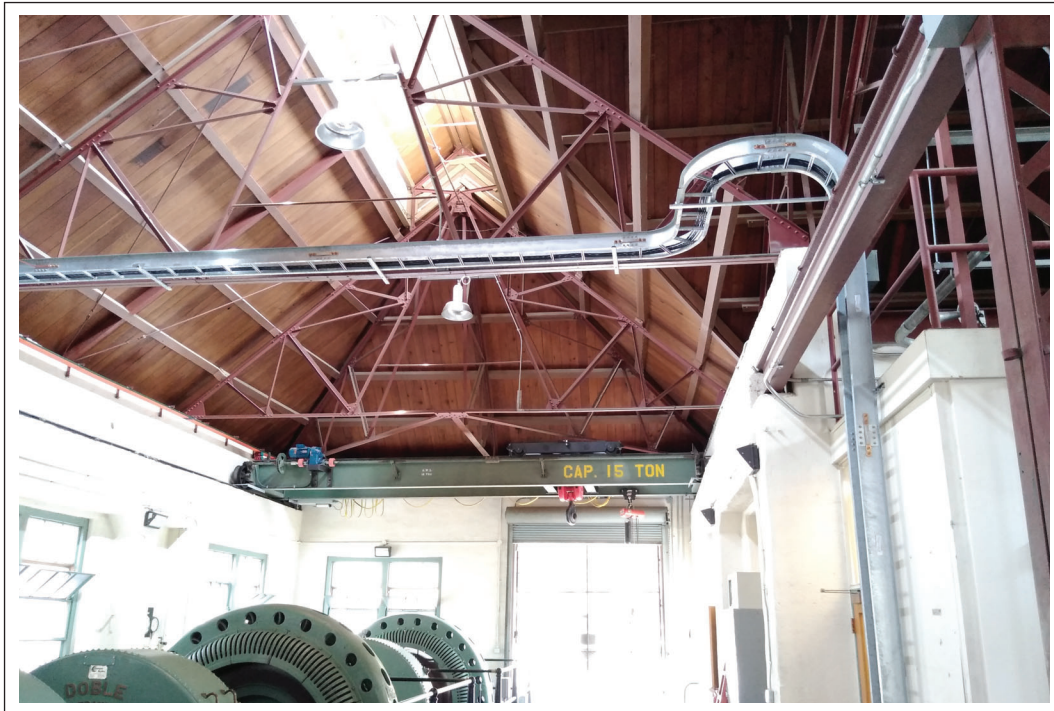
Attachment B-5

Powerhouse No. 4: Interior view of the powerhouse facing northwest. No sign of bat roosting was observed at this facility.

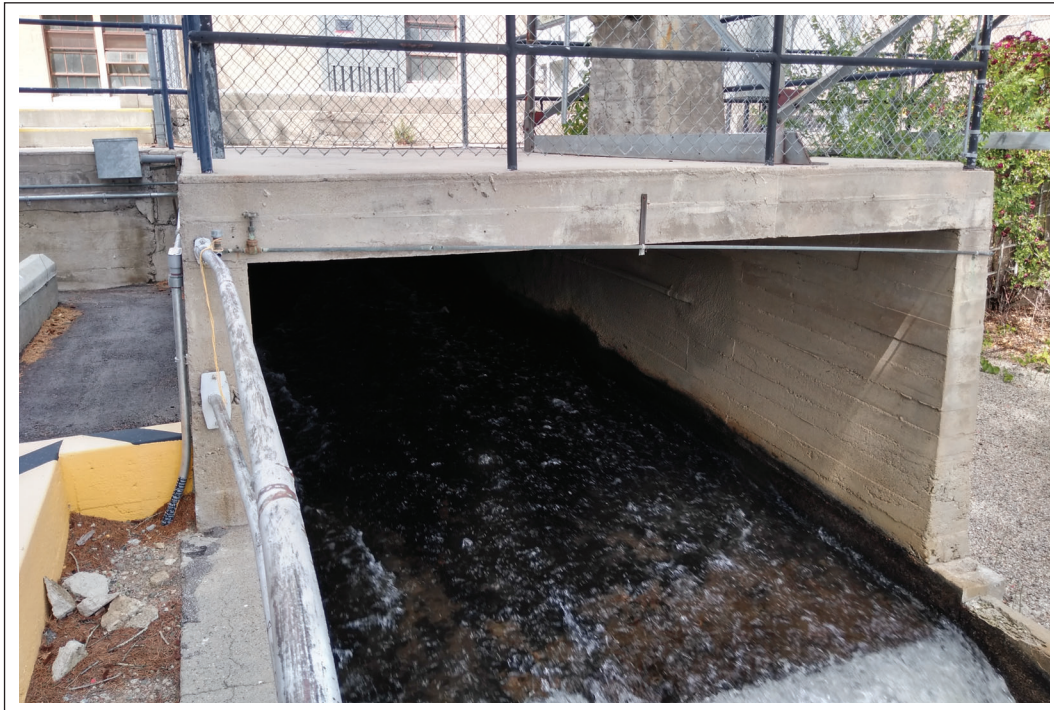
Powerhouse No. 4: View of the tailrace facing west. This larger tailrace does not completely inundate during facility flushing events leaving potentially suitable bat roosting habitat.

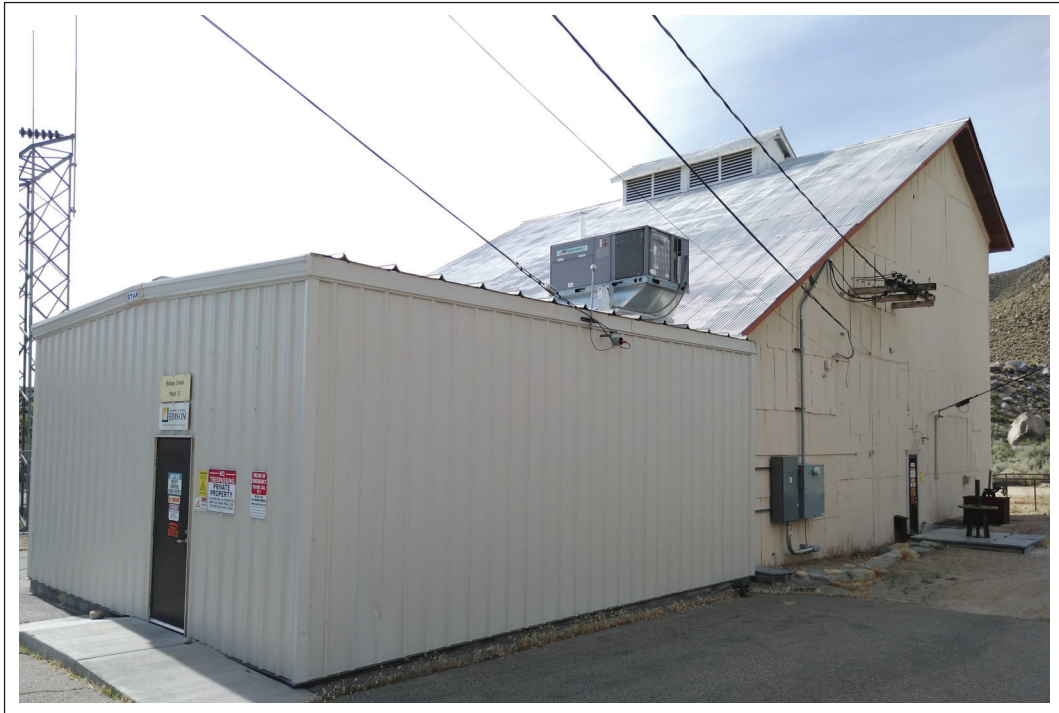
Attachment B-6

Powerhouse No. 5: Exterior view of the powerhouse facing southeast. The powerhouse is presumed to be supporting an active maternity roost.

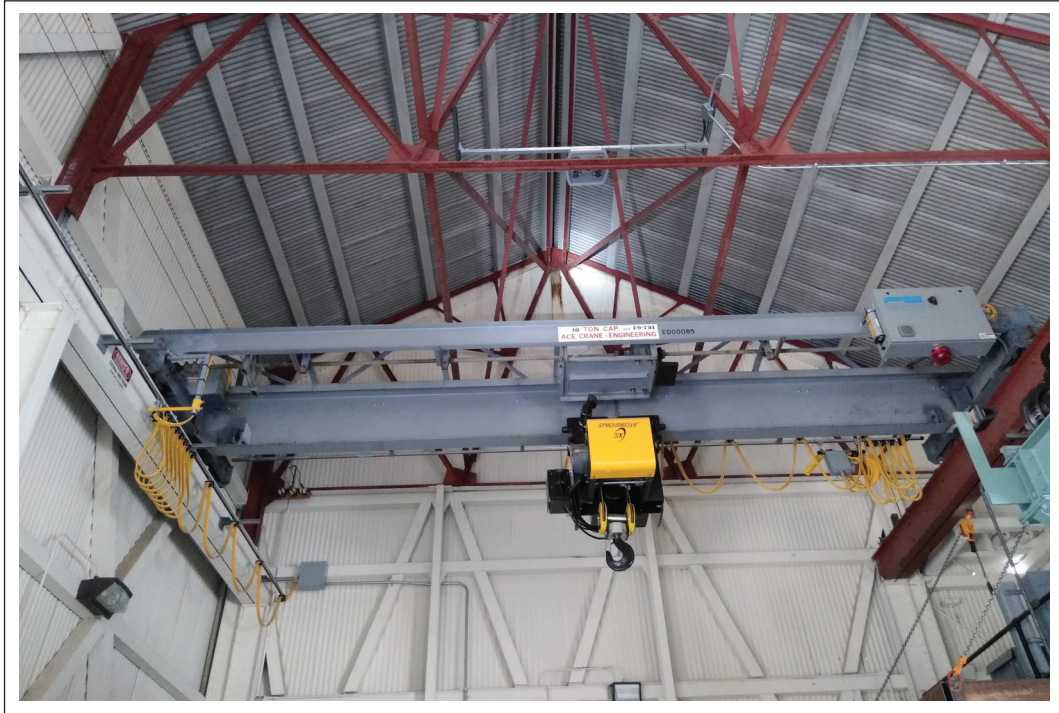
Powerhouse No. 5: Interior view of the powerhouse facing west. The active roost is located in the steel gusset at the peak of the roof highlighted by the flashlight beam in the photograph.

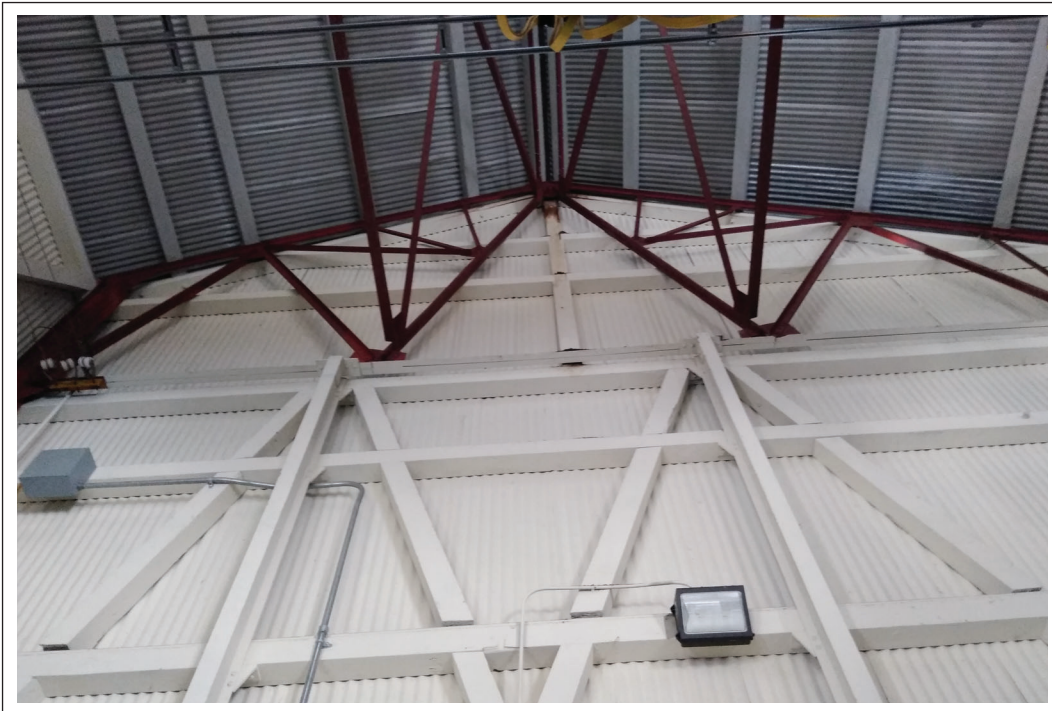
Attachment B-7

Powerhouse No. 5: Interior view of the powerhouse facing west. Guano accumulation is visible on the white beams below the roost in the dark gusset. Dark urine staining is also visible below the gusset.

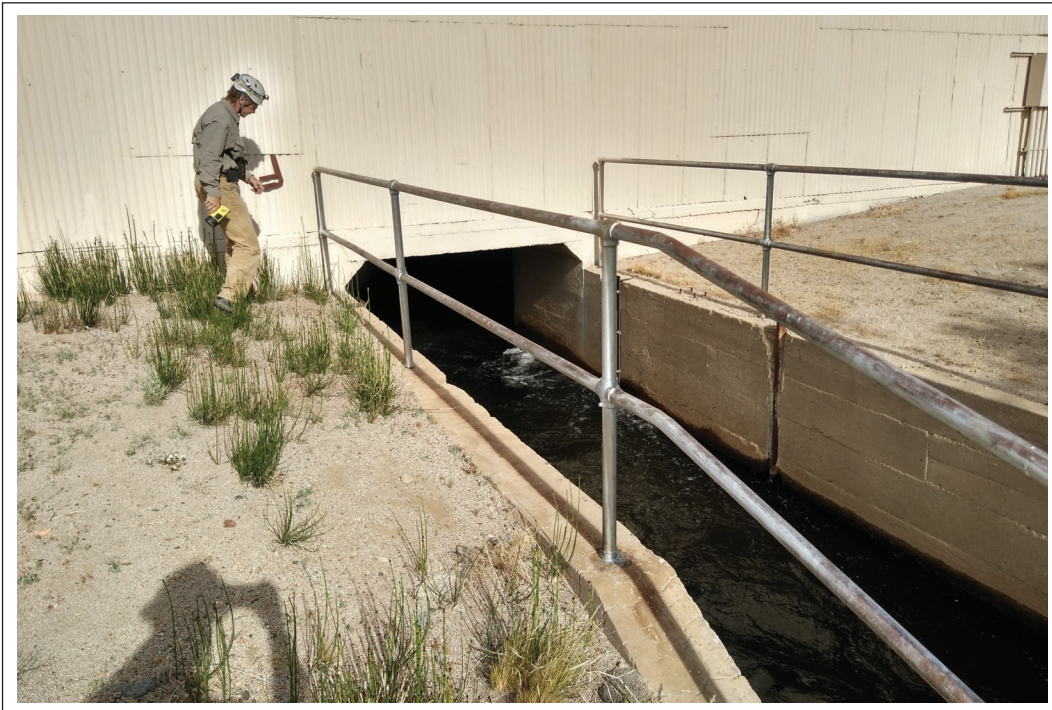
Powerhouse No. 5: View of the tailrace facing west. This larger tailrace does not completely inundate during facility flushing events leaving potentially suitable bat roosting habitat.

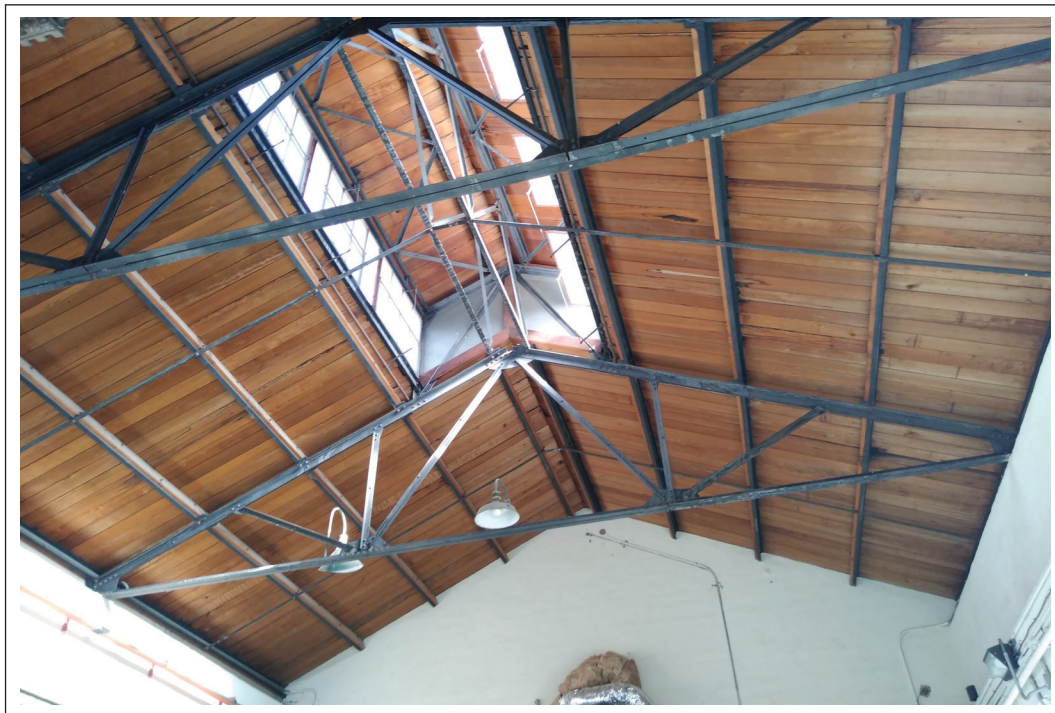
Attachment B-8

Powerhouse No. 6: Interior view of the powerhouse facing northwest. No sign of bat roosting was observed at this facility.
