**SOUTHERN CALIFORNIA EDISON
Lee Vining Hydroelectric Project
(FERC Project No. 1388)**

**GENERAL WILDLIFE RESOURCES SURVEY
(TERR-2) FINAL TECHNICAL REPORT**

EXISTING RECREATION FACILITIES CONDITION ASSESSMENT (REC-2) FINAL TECHNICAL REPORT

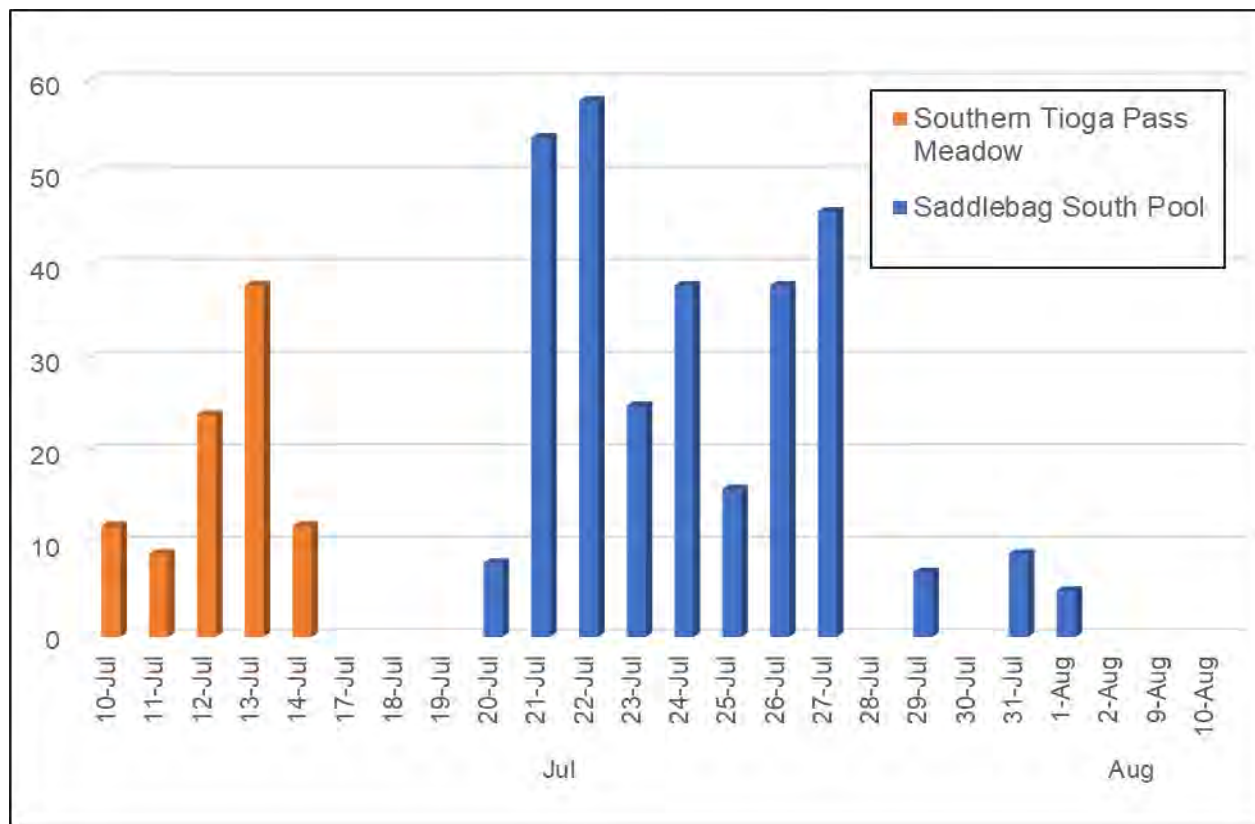
Figure 5.4-1. Yosemite Toad Breeding Calls Recorded Daily.

The audio recorders were determined to have a recordable range between approximately 50 to 100 feet (15 to 30 meters). This range was not systematically tested but all calls at or greater than 100 feet (30 meters) away were subsequently determined to be out of range of the recorders. Figure A-4 in Attachment A shows the location of the audio recorders in relation to the potential breeding habitat observed.

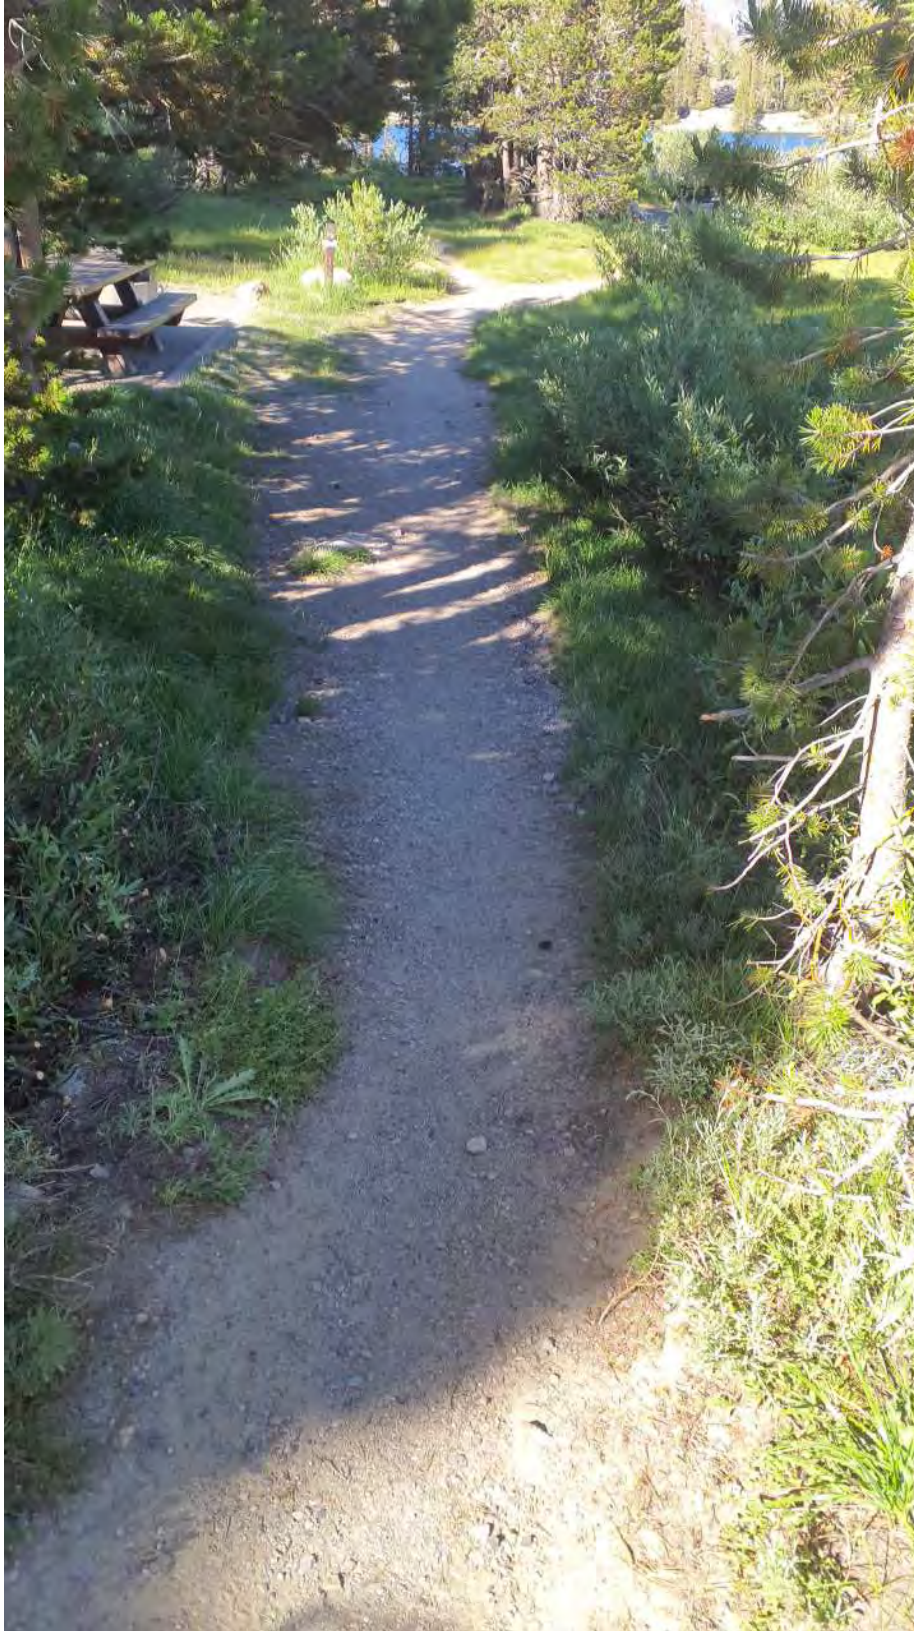
Photo 35. Tioga Lake Campground, Trampled Vegetation

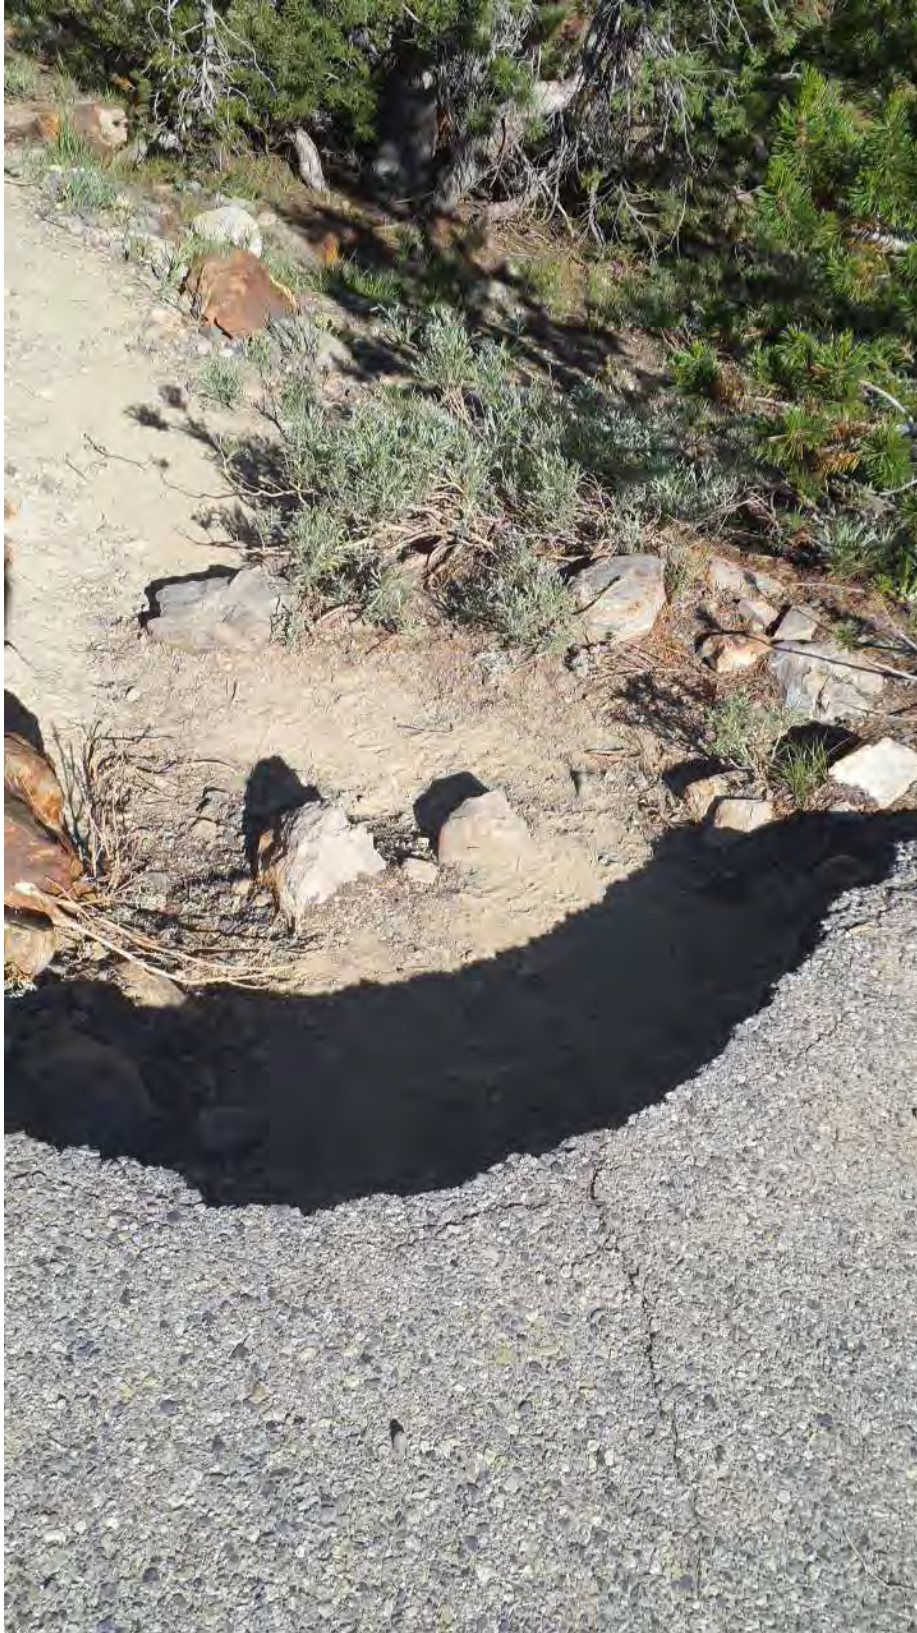
Photo 36. Tioga Lake Campground, Erosion

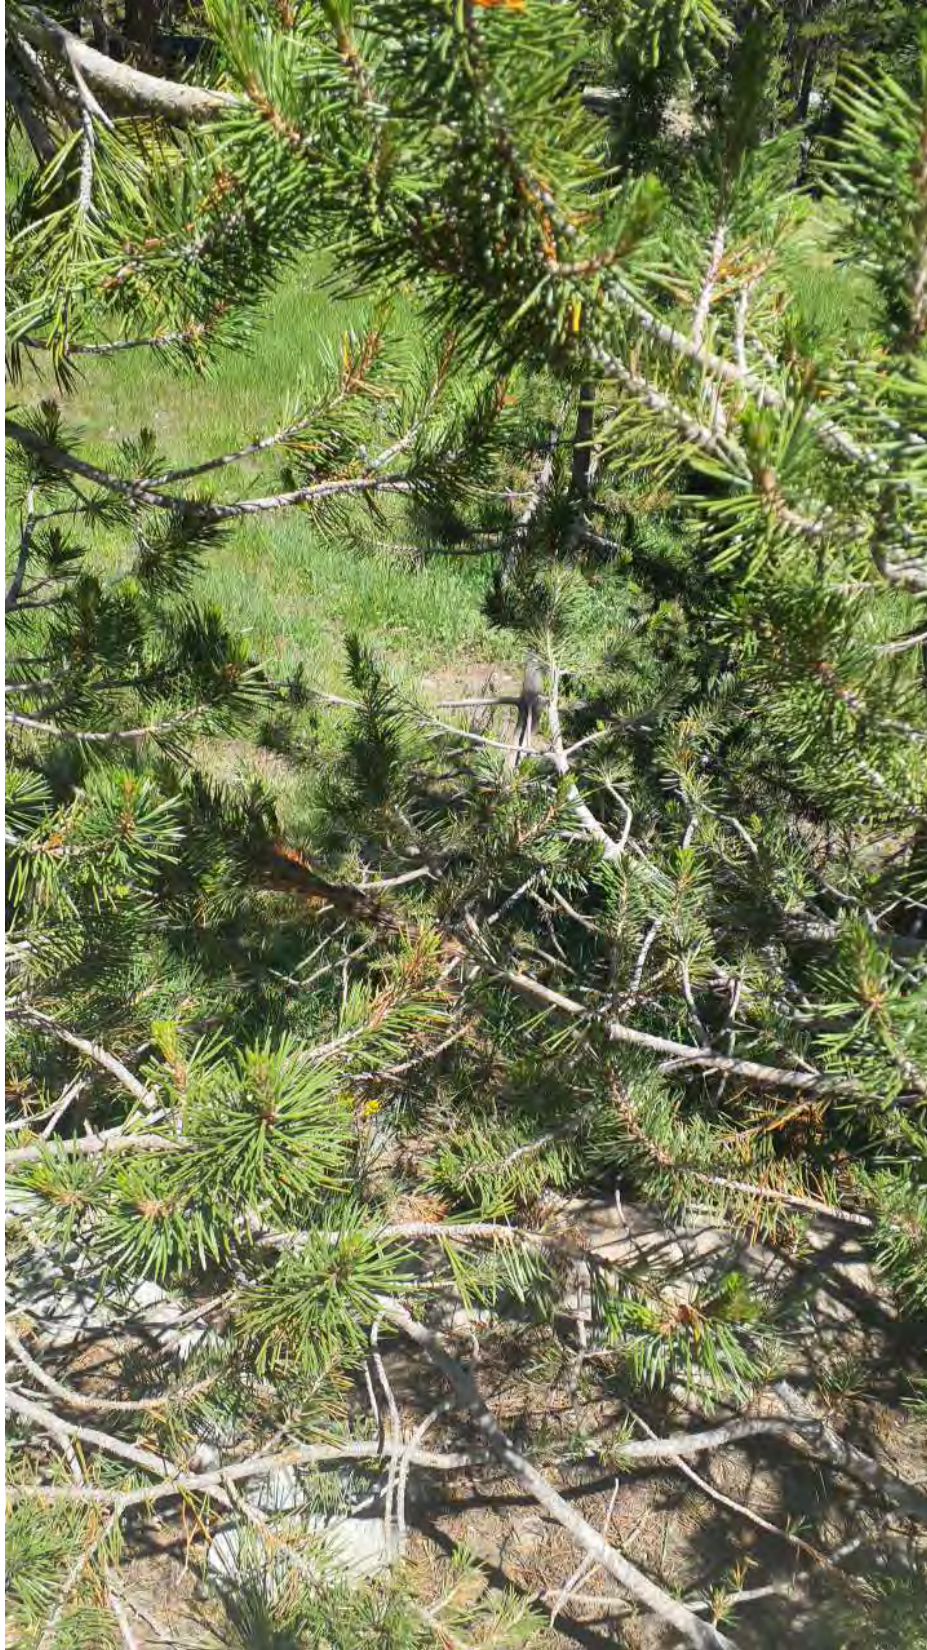
Photo 65. Junction Campground, Tree over trail

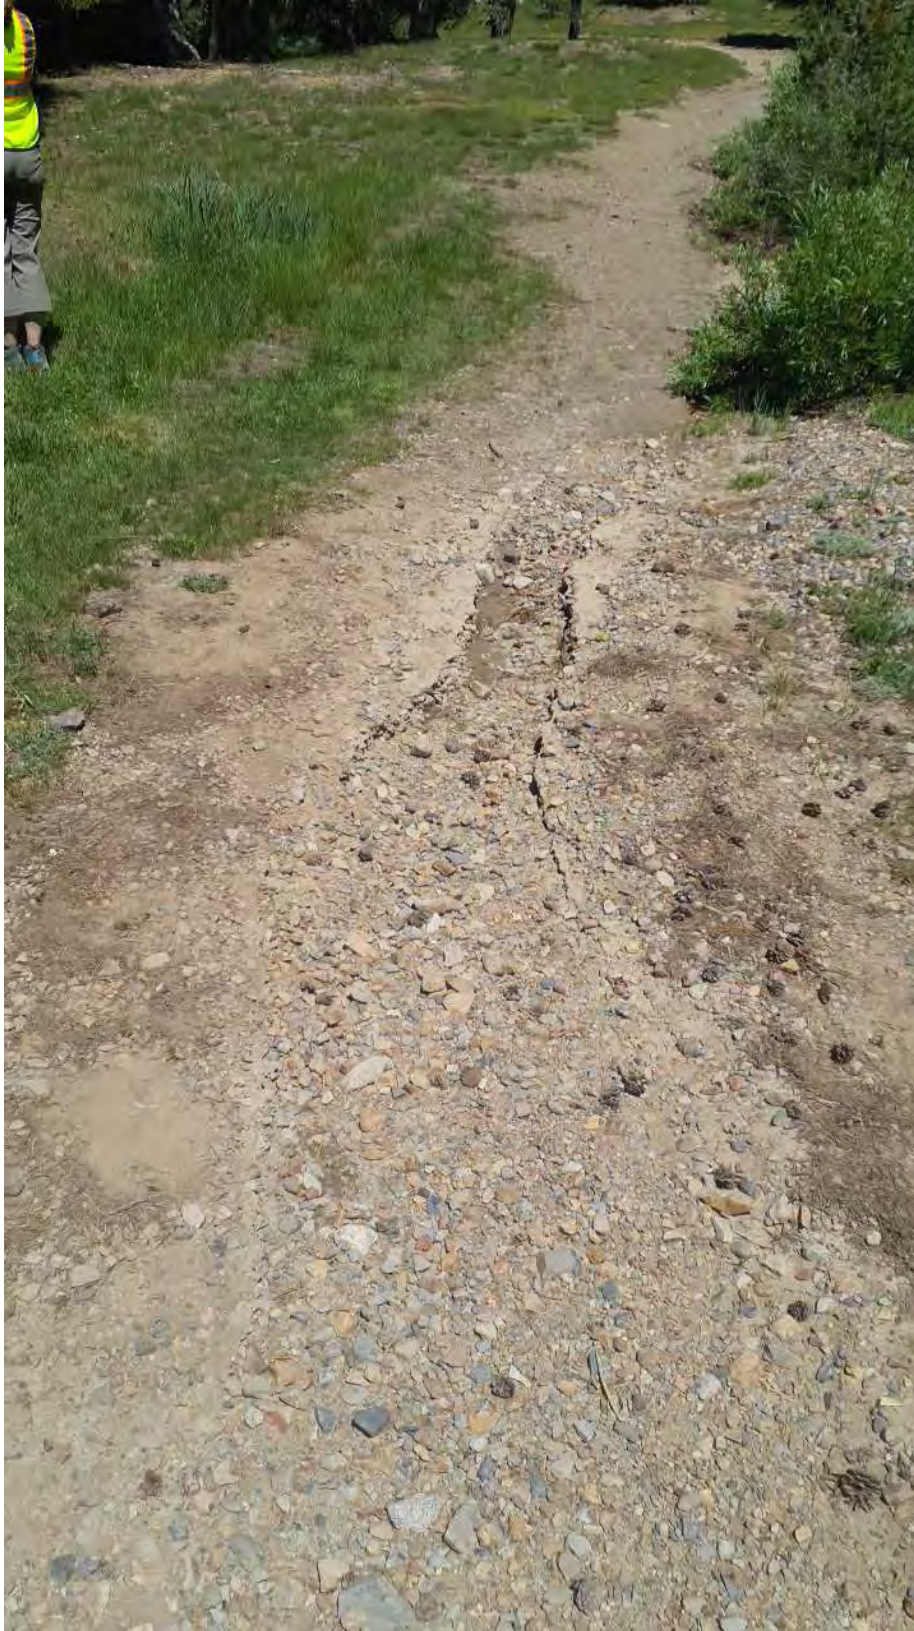
Photo 74. Sawmill Walk-In Campground, Erosion
